PLAN SHOWING A PART OF THE WORK
DONE IN OAK ISLAND, N.S. PREVIOUS
TO THE YEAR 1795 A.D.

OAK ISLAND - NOVA SCOTIA EXPLORATION

Sketches from the OAK ISLAND TREASURE COMPANY
Prospectus, showing work done prior to 1893

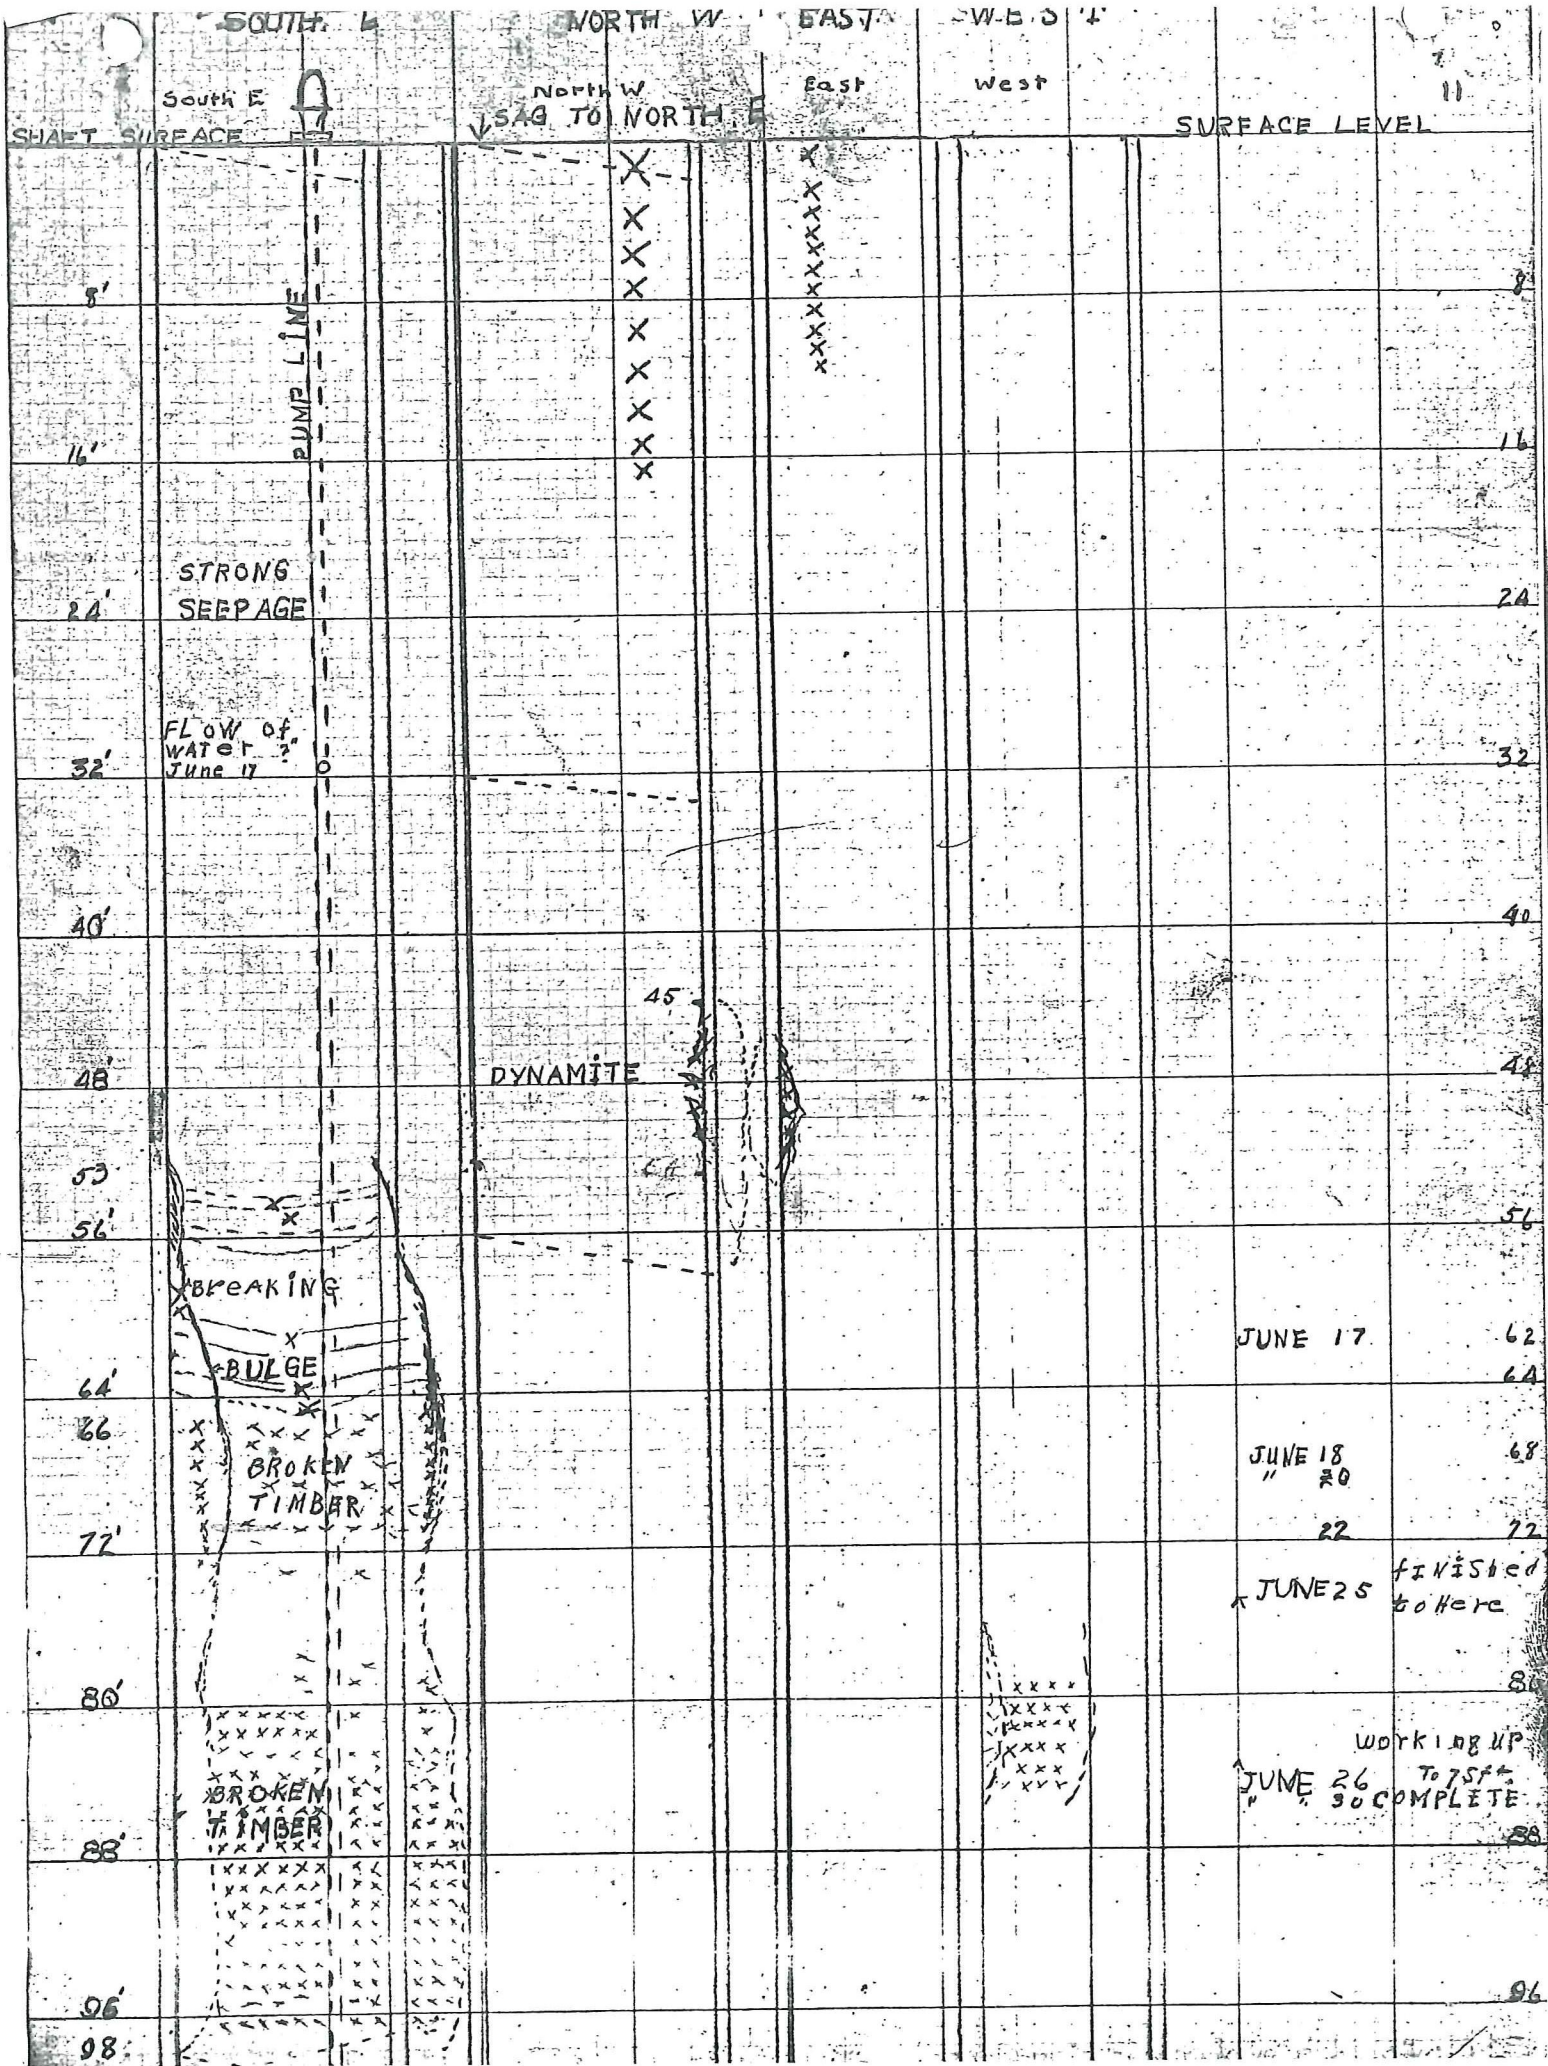
Today I brought out a crew of men and I descended to a point between 95 and 100 ft where I found the South West corner & sides jammed with old timber and the 6"x6" used in original shaft broken and pushed in about three feet, a 6"x6" timber was jammed endways against pump line gradually crowding it out of line.

Most of the timber which cross braces the shaft are broken or shoved out of place, as far down below this point as I could see. A considerable amount of old lumber is lodged along South East end making inspection uncertain and difficult till shaft is retimbered with new lumber down to this point.

July 10: We cleared away a mass of broken timber and bulging earth and caught up the caved area down to 110 ft. In this operation it was necessary to timber around pump line to prevent the South and West walls pushing in and destroying the entire pump system.

Nine pieces of 6"x6" timbers were crowded against the pump line pushing it out of plumb. These all had to be carefully cut away and new timbers substituted.

Three men lowered me into the shaft below this wreckage in a life line, where I sawed away timbers and dislodged broken lumber and sent it to surface. Later we realigned the pump at head of shaft.

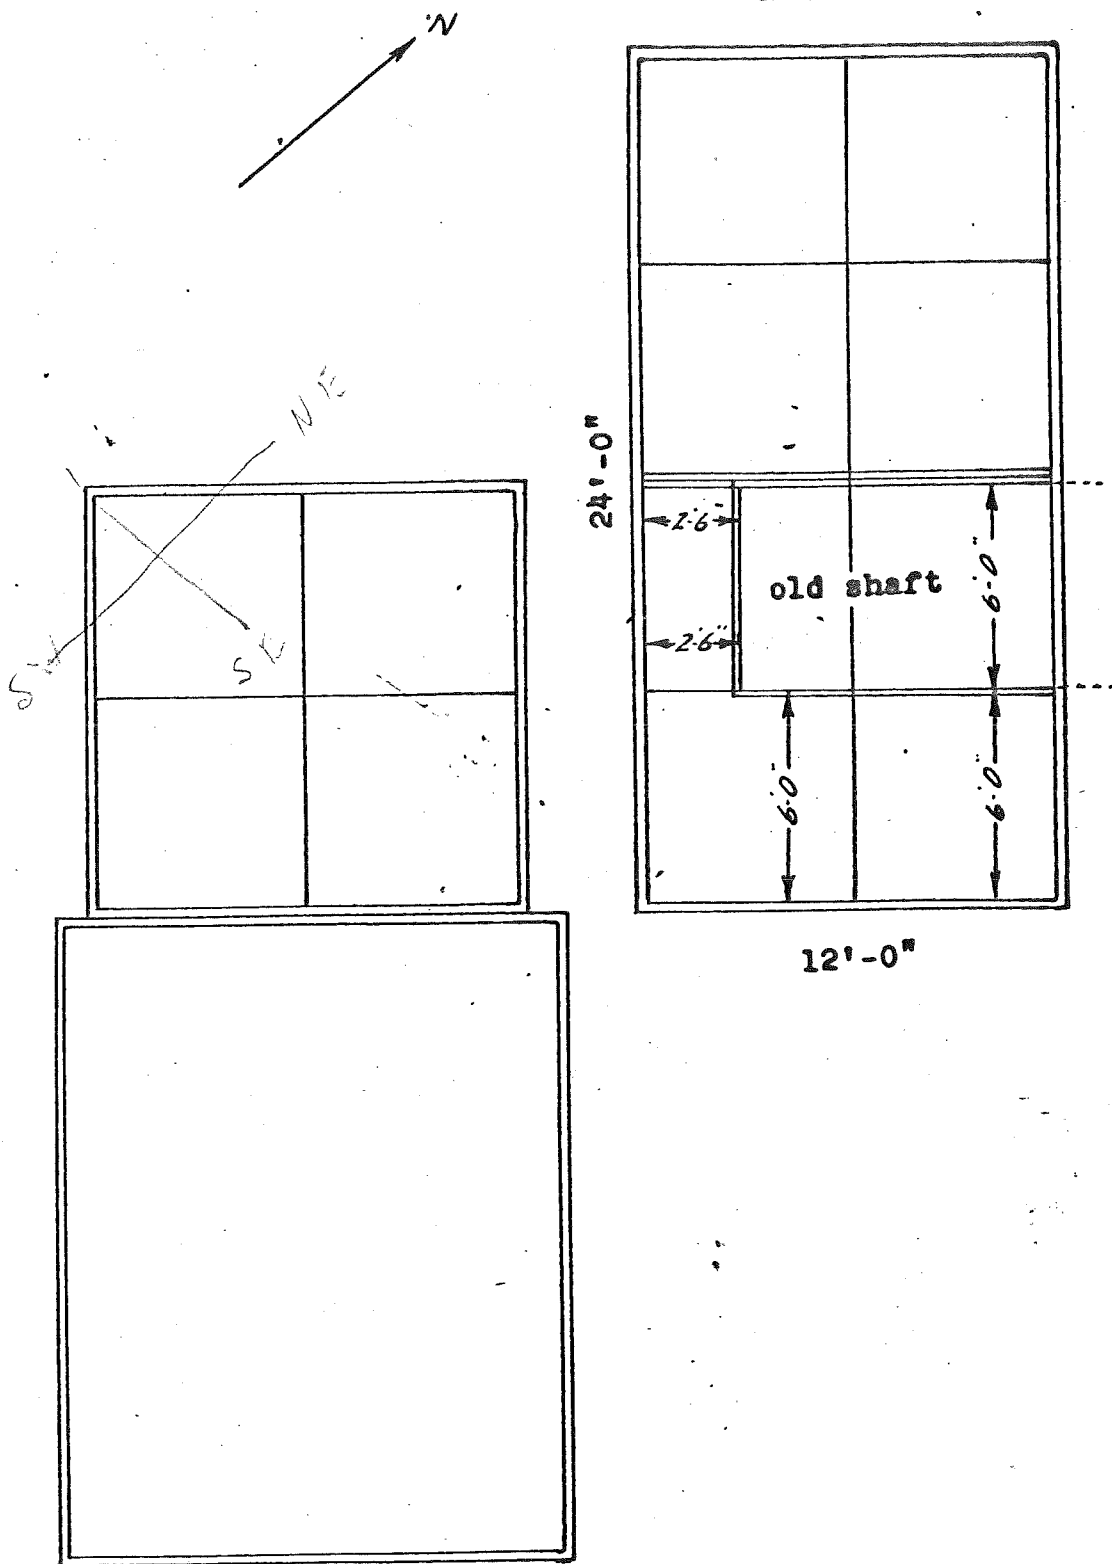
POSITION AT 20' Below collar of shaft or Deck

At about ten feet the well defined outline of an old shaft began to appear. This shaft had been filled in with gravel and coal ashes and other waste matter from other diggings.

At twenty feet an accurate measurement was taken of the old shaft, and was found to be 6 ft wide with about ten feet of its length showing, as it extends beyond the North E wall of the new shaft.

The old shaft had been timbered with double three inch planking.

On the South side of new shaft it is 2.6" from wall of new shaft and extending west for 6.0". then North past line of North wall of new shaft then East for 6.0" (width of old shaft) then South to starting point. On the Eastern end it is 6.0" West of new shaft.

The planking in old shaft are fairly well preserved.

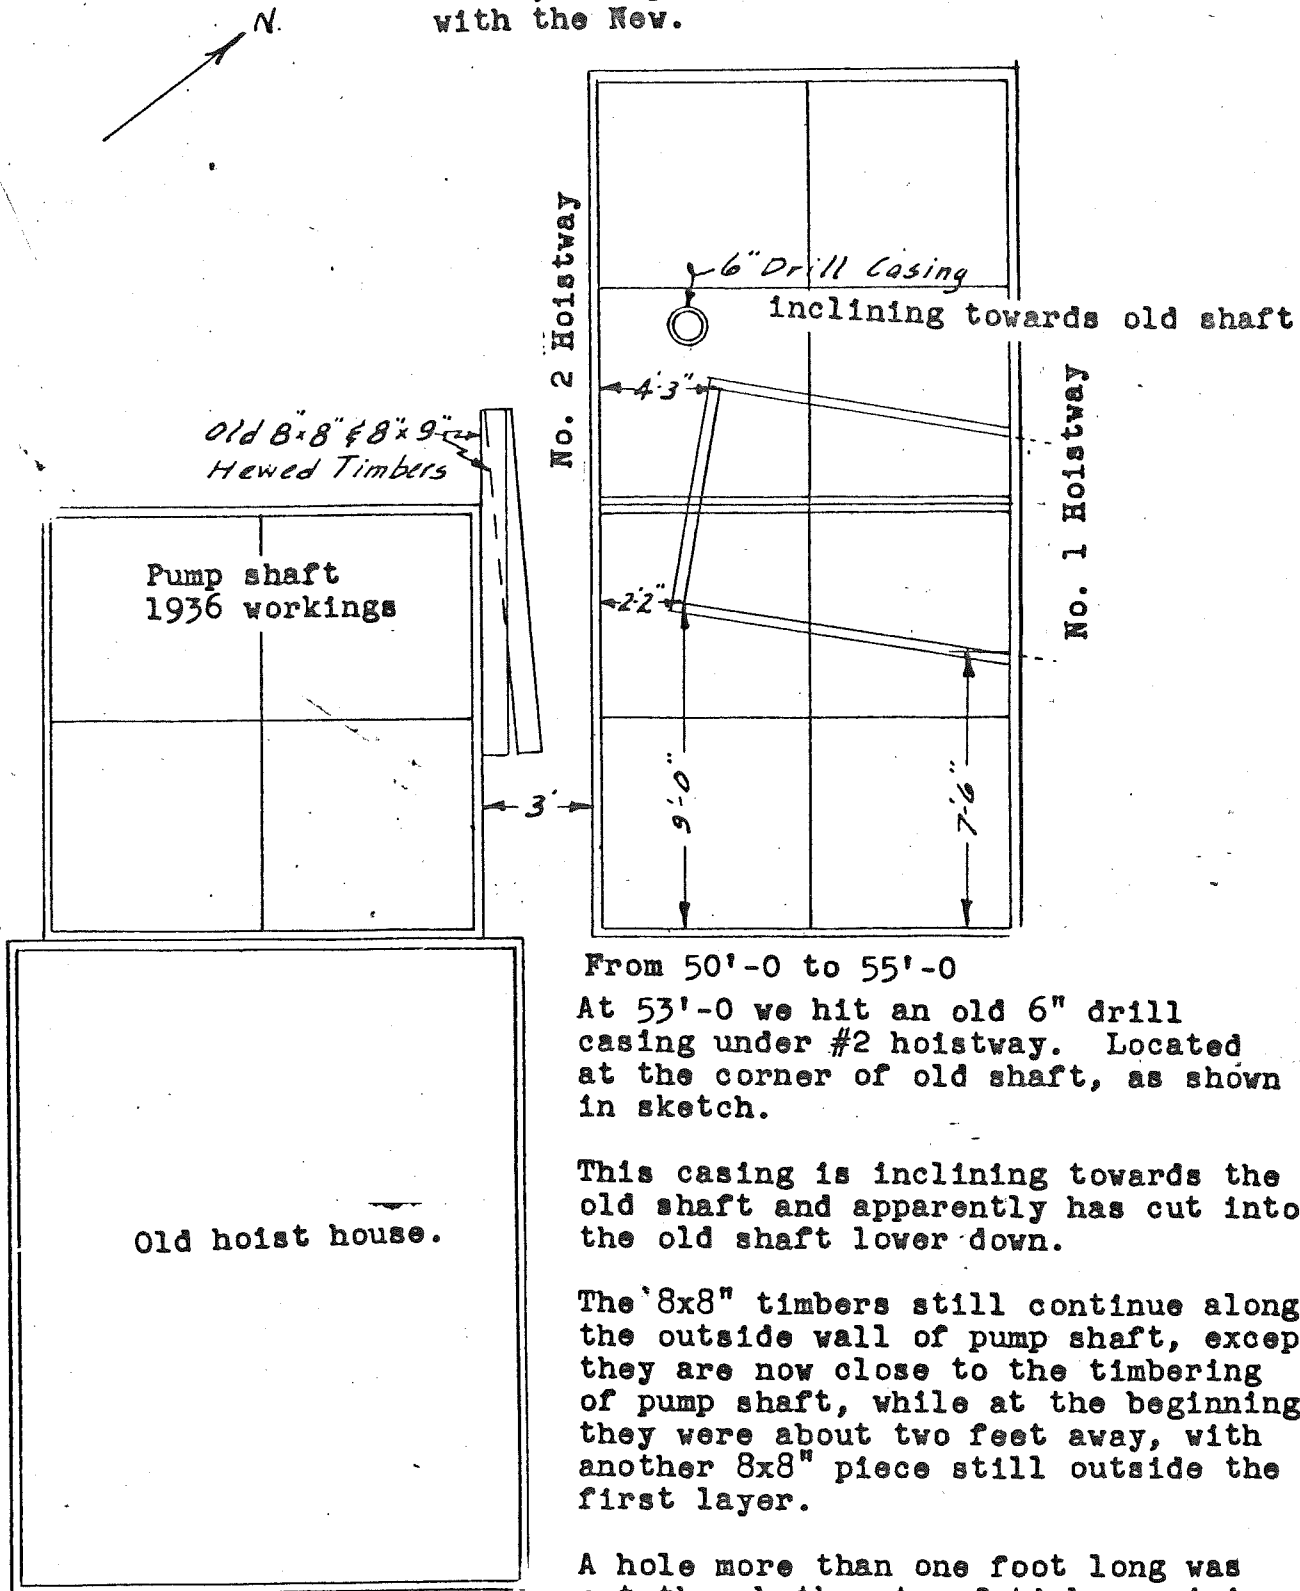
POSITION AT 55'

At 53'-0 we hit an old 6" drill casing under #2 hoistway. Located at the corner of old shaft, as shown in sketch.

This casing is inclining towards the old shaft and apparently has cut into the old shaft lower down.

The '8x8" timbers still continue along the outside wall of pump shaft, except they are now close to the timbering of pump shaft, while at the beginning they were about two feet away, with another 8x8" piece still outside the first layer.

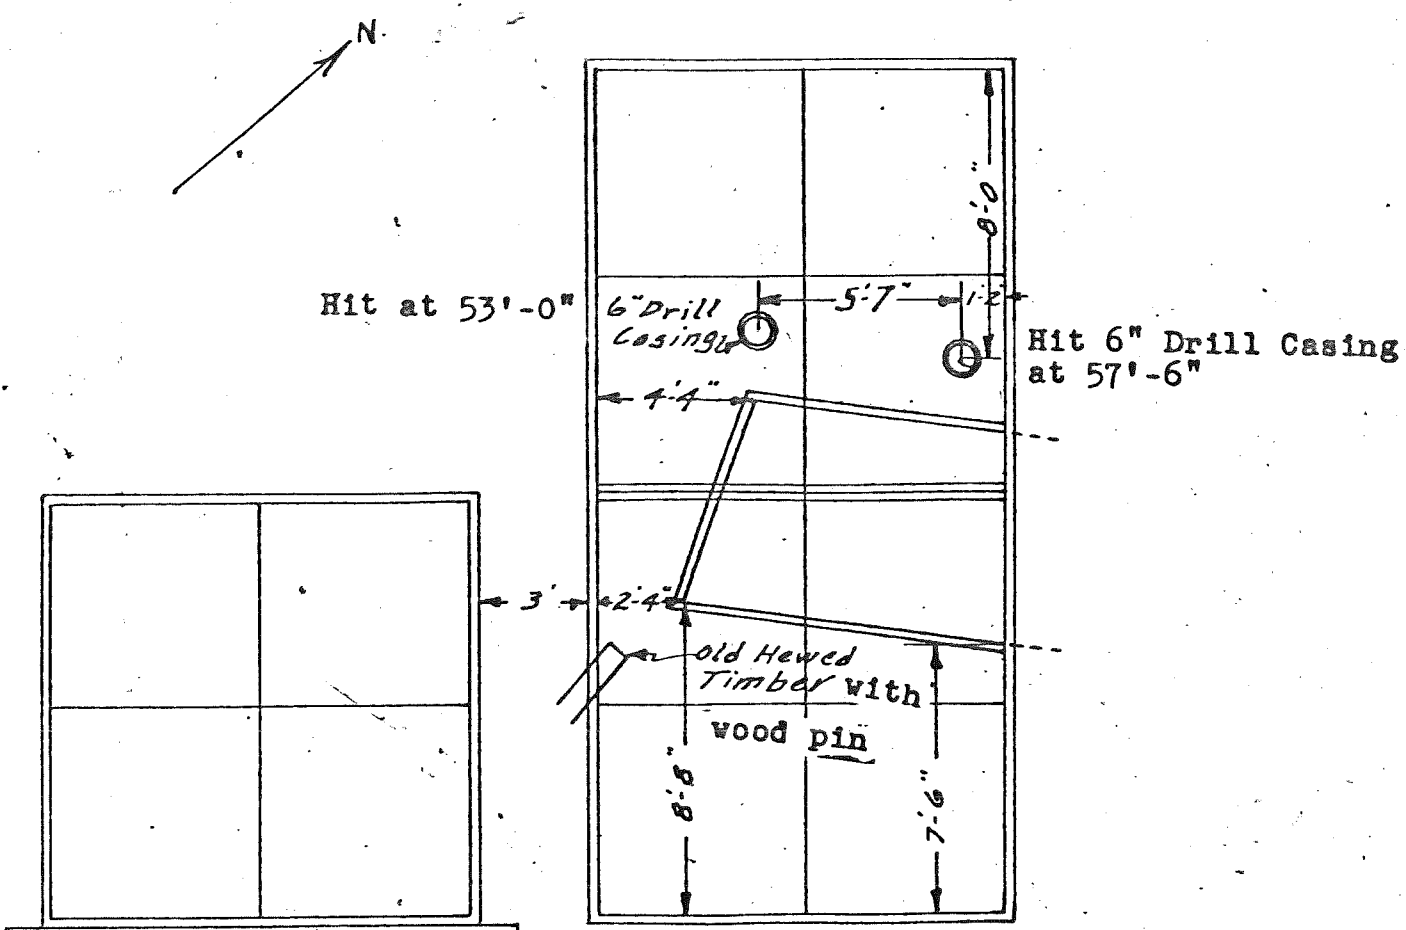
POSITION AT 60'

At 57-6" we came to another 6" drill casing cutting the edge of the old shaft. Its exact position is shown in the above sketch.

When the casing was first opened it carried off all the water lying in bottom of shaft, and filled up to 3-6" from top where water remained.

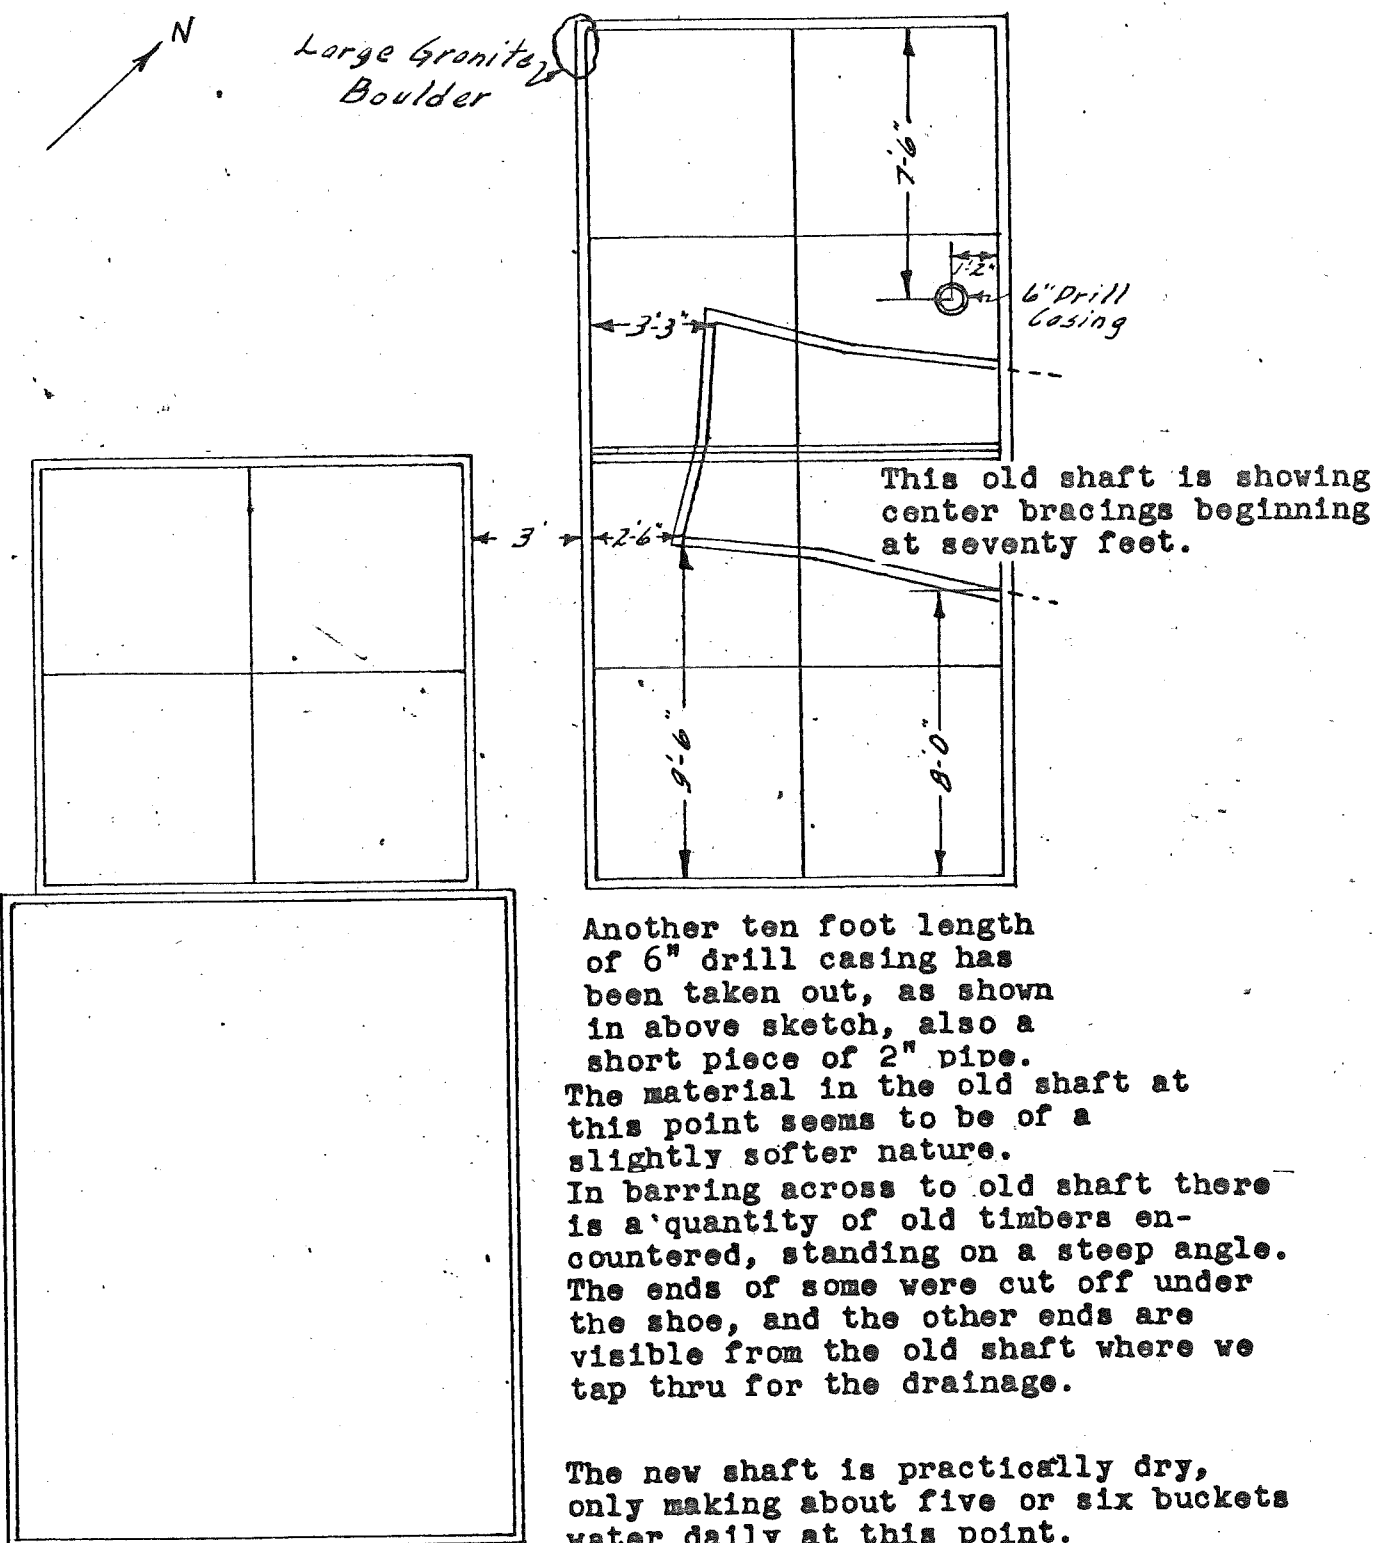
POSITION AT 75'

This old shaft is showing center bracings beginning at seventy feet.

Another ten foot length of 6" drill casing has been taken out, as shown in above sketch, also a short piece of 2" pipe. The material in the old shaft at this point seems to be of a slightly softer nature. In barring across to old shaft there is a quantity of old timbers encountered, standing on a steep angle. The ends of some were cut off under the shoe, and the other ends are visible from the old shaft where we tap thru for the drainage.

The new shaft is practically dry, only making about five or six buckets water daily at this point.

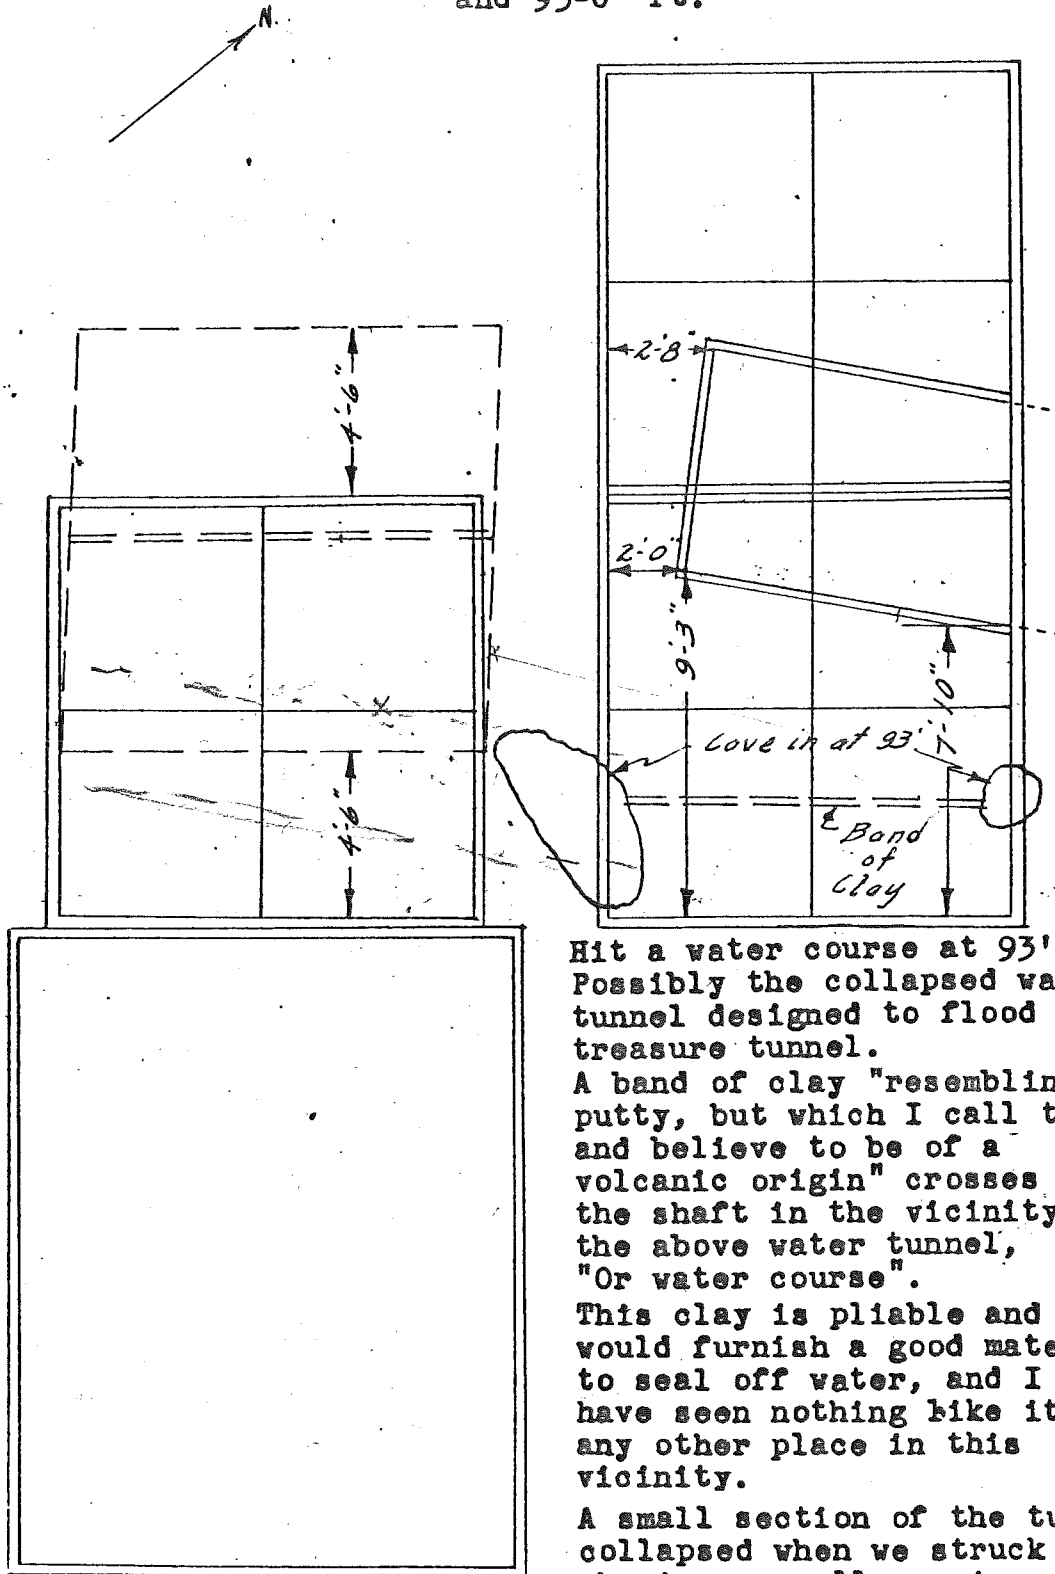
POSITION AT 95'

Hit a water course at 93'-0"
 Possibly the collapsed water
 tunnel designed to flood
 treasure tunnel.
 A band of clay "resembling
 putty, but which I call talc,
 and believe to be of a
 volcanic origin" crosses
 the shaft in the vicinity of
 the above water tunnel,
 "Or water course".
 This clay is pliable and
 would furnish a good material
 to seal off water, and I
 have seen nothing like it in
 any other place in this
 vicinity.
 A small section of the tunnel
 collapsed when we struck it
 showing a small opening as in
 above sketch.

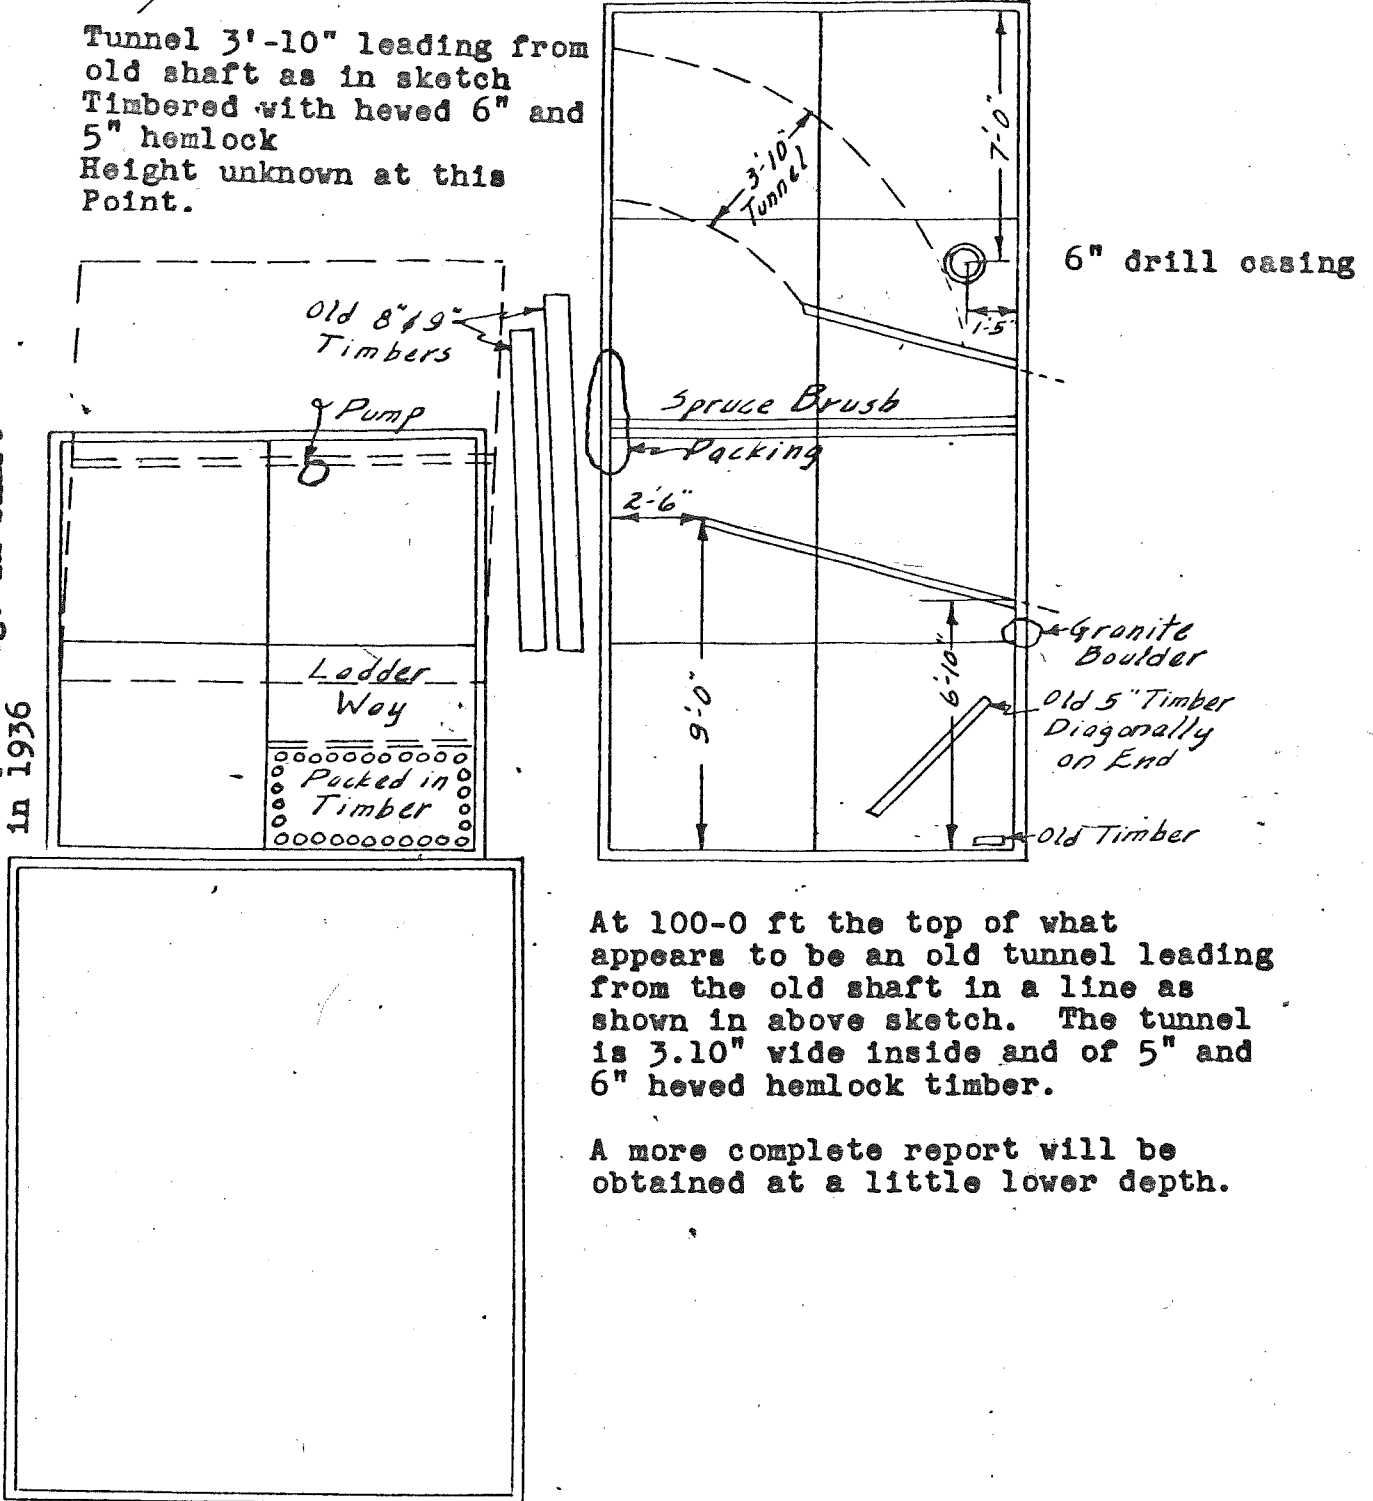
POSITION AT 100'

Tunnel 3'-10" leading from old shaft as in sketch
Timbered with hewed 6" and 5" hemlock
Height unknown at this Point.

Old timber packed in to stop a bulge in shaft in 1936

At 100-0 ft the top of what appears to be an old tunnel leading from the old shaft in a line as shown in above sketch. The tunnel is 3.10" wide inside and of 5" and 6" hewed hemlock timber.

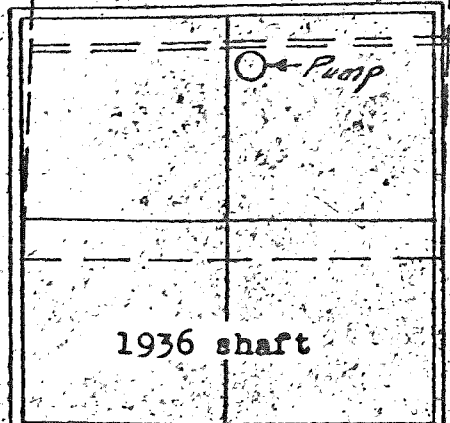
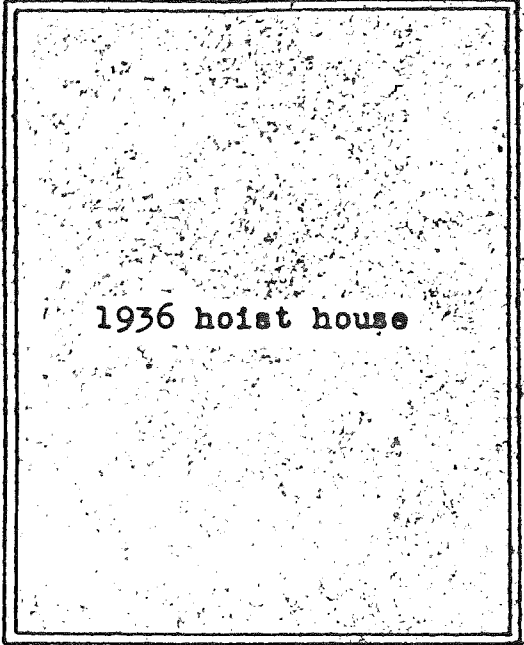
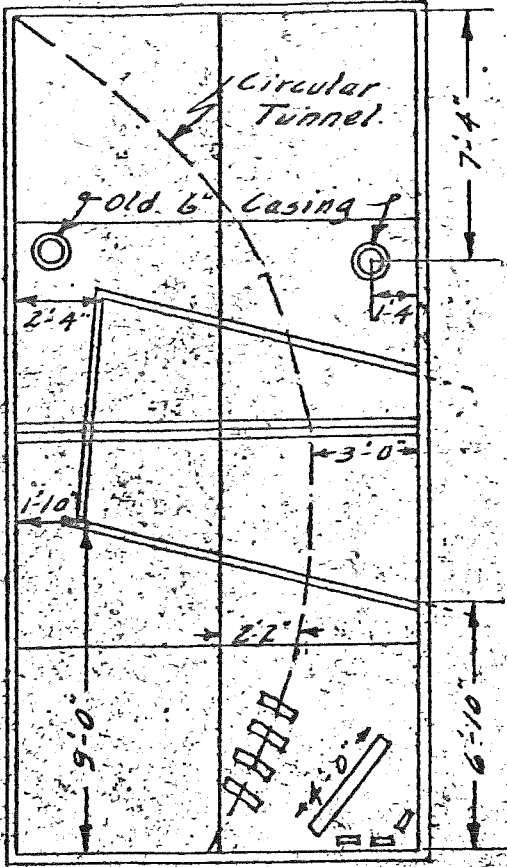
POSITION AT 101'-6"

shaft deflected 4-6" as shown in dotted line

old Timbers packed between shafts.

Circular tunnel cutting across shaft as shown in above sketch.

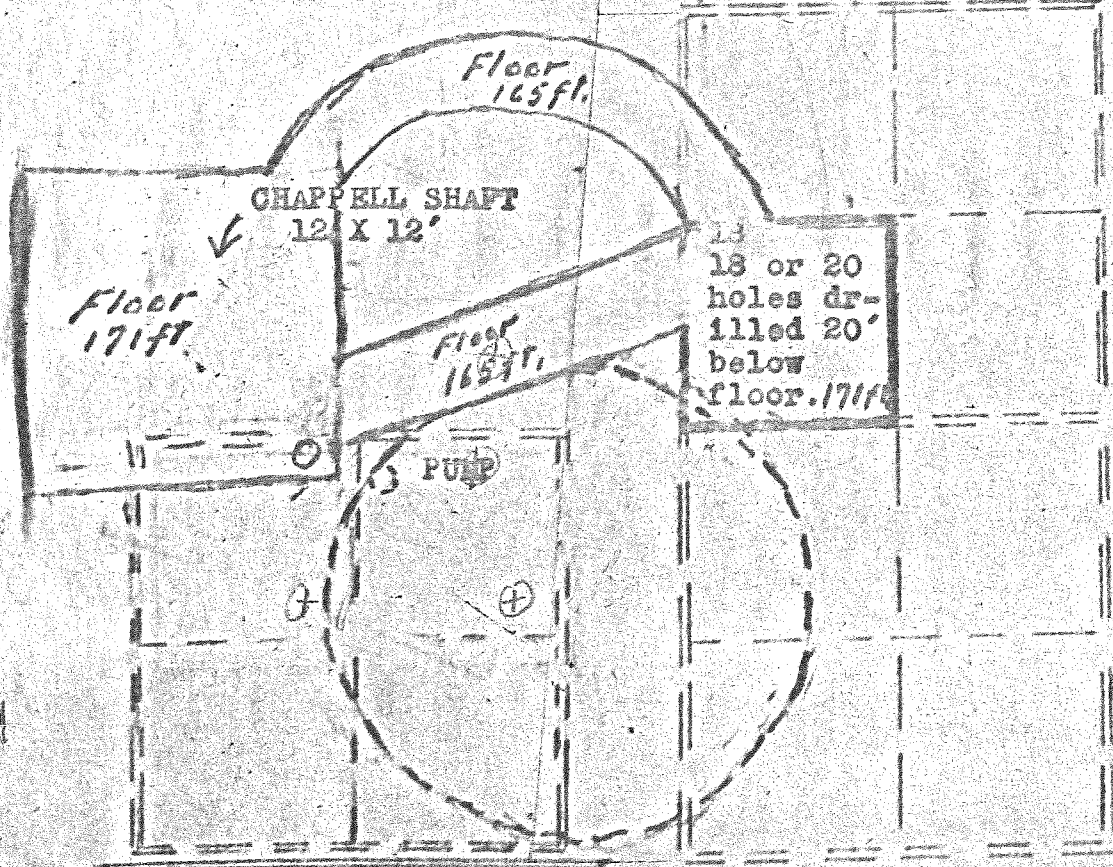
POSITION AT 170'

The 6X6' compartment in the Hedden Shaft was deepened from 121' to 170'.

The floors in both shafts were in solid ground.

The holes drilled in the bottom of this shaft were in part inclined to the SW but not inclined more than 10°. They penetrated gravel and soft material.
