PLAN SHOWING A PART OF THE WORK
DONE IN OAK ISLAND, N.S. PREVIOUS
TO THE YEAR 1795 A.D.

OAK ISLAND - NOVA SCOTIA EXPLORATION

Sketches from the OAK ISLAND TREASURE COMPANY
Prospectus, showing work done prior to 1893

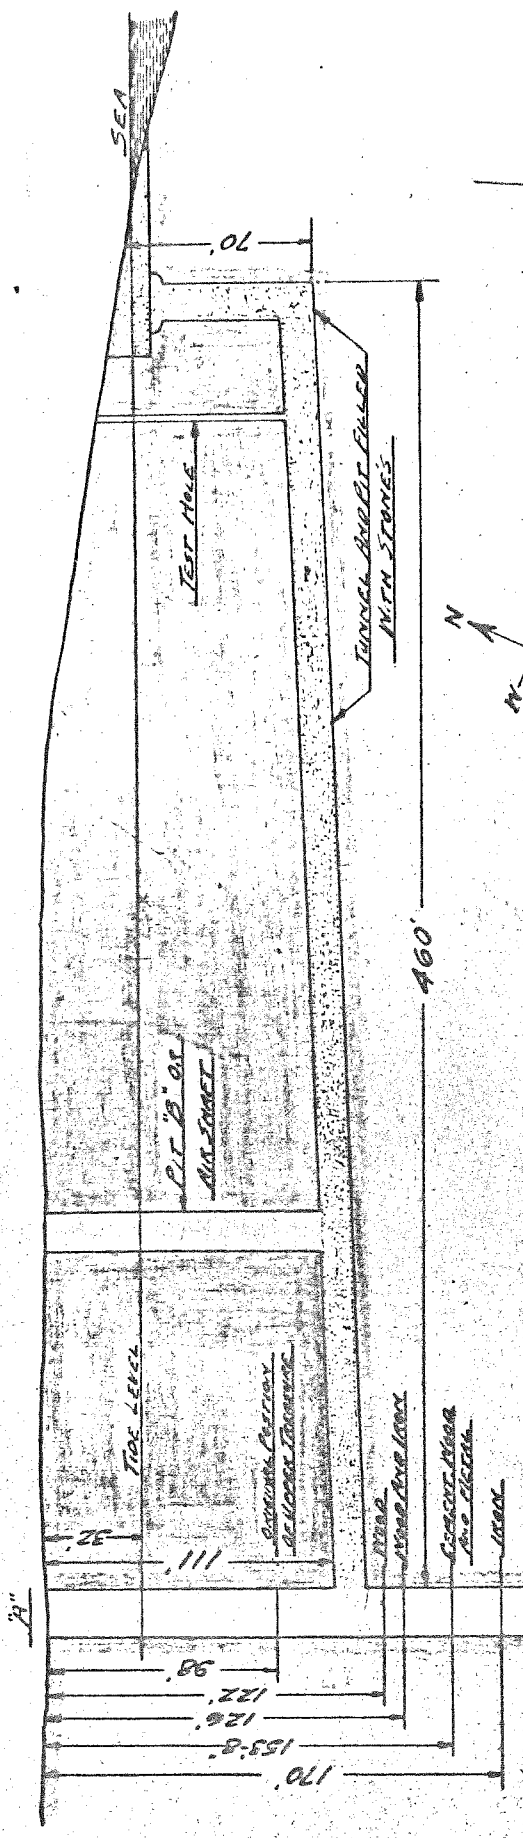
ELEVATION

OAK BOXES AND CHARRELS - TWO
BOXES WERE BURIED THROUGH
EACH 22" DEEP HOLE, AND FULL
OF "METAL IN PIECES"

Money pit
is filled
with puddled
blue clay
from:
130 to 151ft.
and from
160 to 171 ft.

OAK BOX ENCLOSED IN CEMENT, WITH
DEPTH 4'-6" - BOX FULL OF "METAL
IN PIECES" - PIECE OF PARCHMENT
RECOVERED FROM THIS BOX.

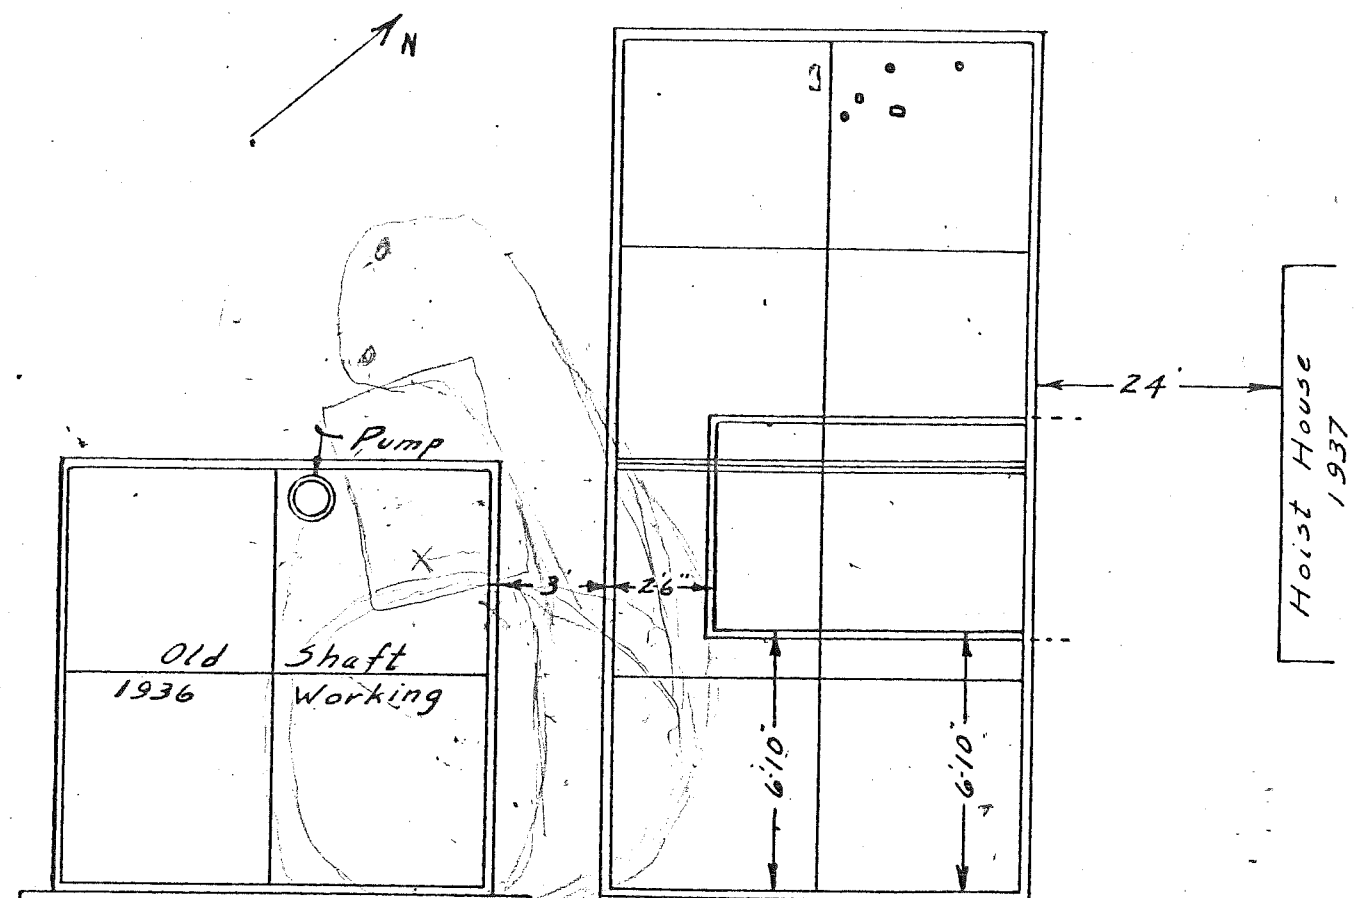
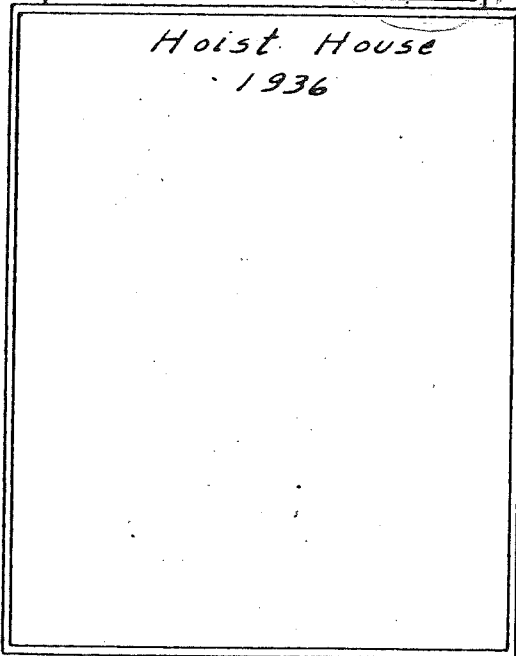
POSITION AT 20' Below collar of shaft or Deck

At twenty feet an accurate measurement was taken of the old shaft, and was found to be 6 ft wide with about ten feet of its length showing, as it extends beyond the North E wall of the new shaft.

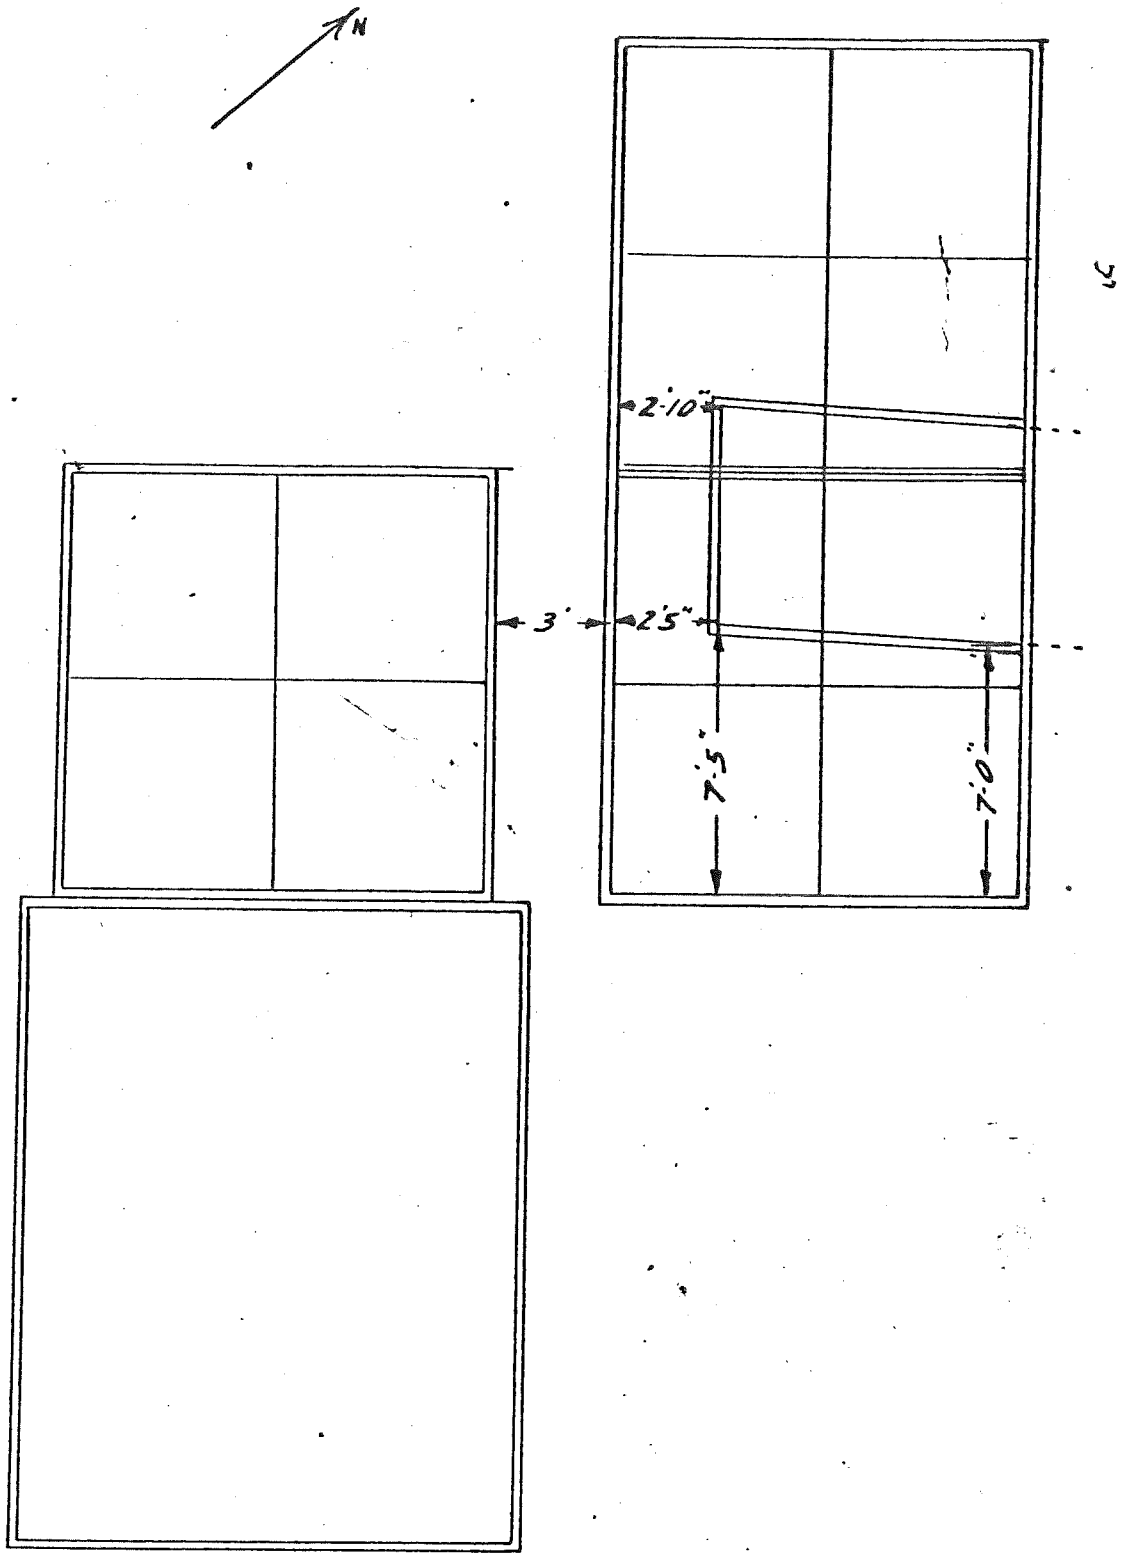
POSITION AT 24'

The old filled shaft at 24' began to lean about ten inches towards the N.W.

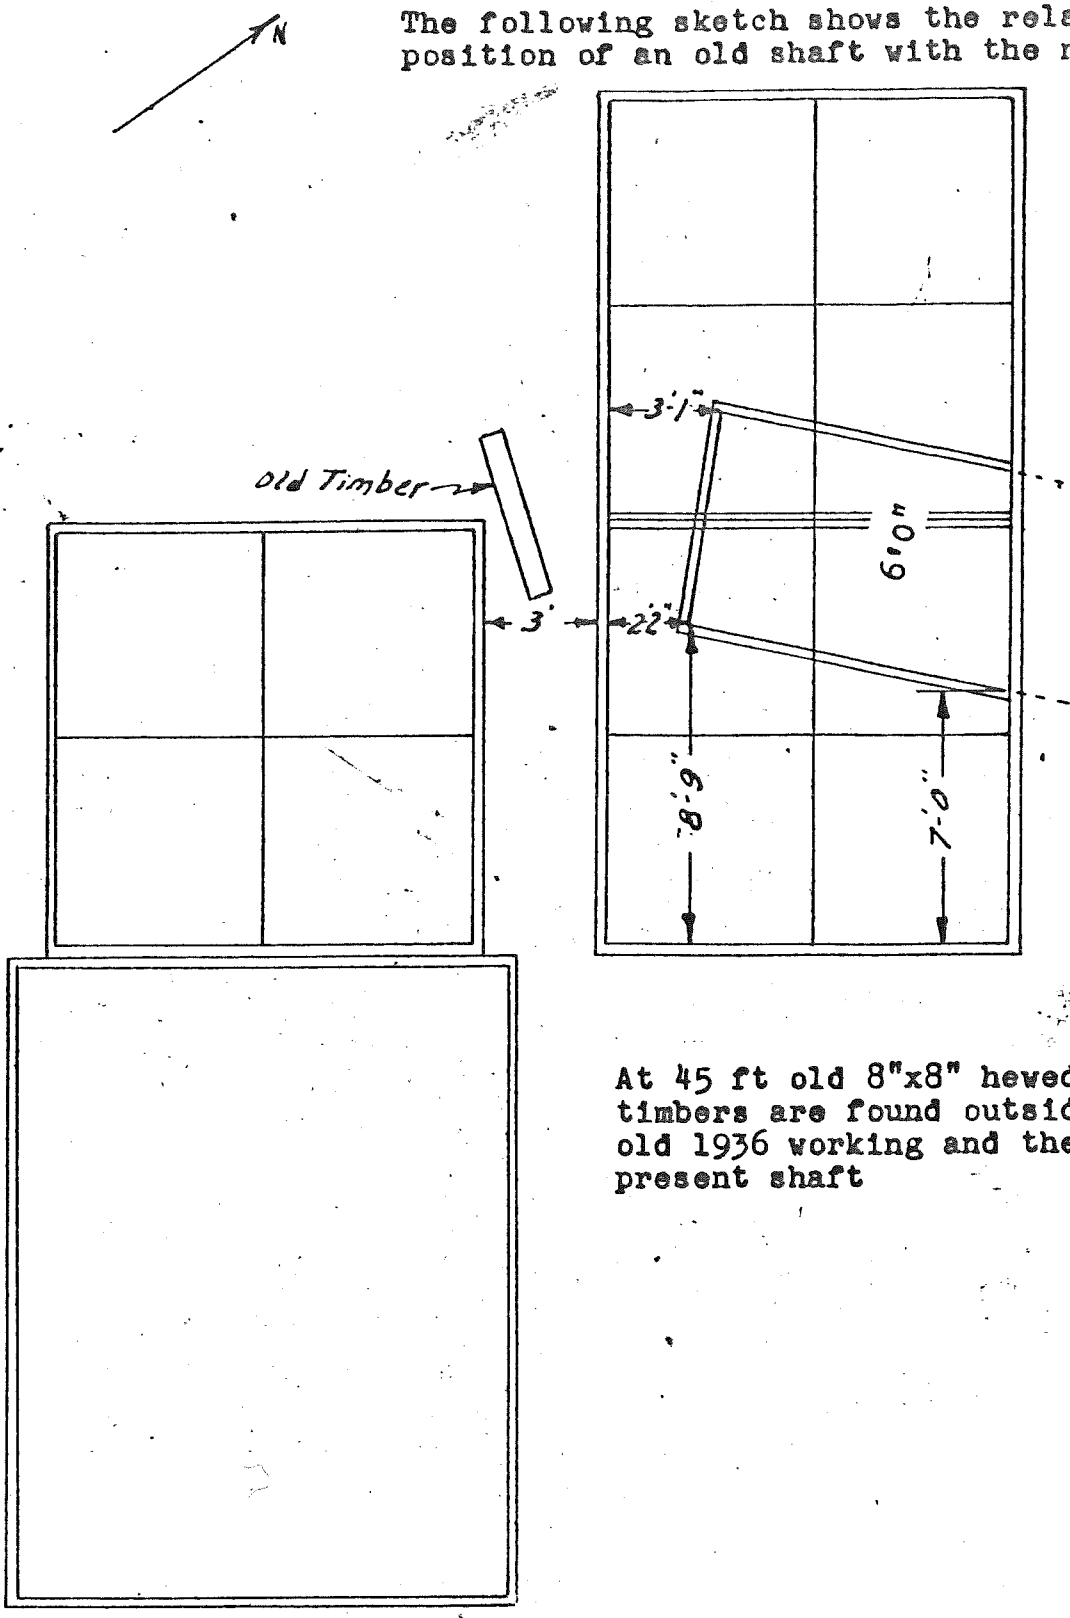
POSITION AT 45'

At 45 ft old 8"x8" hewed timbers are found outside the old 1936 working and the present shaft

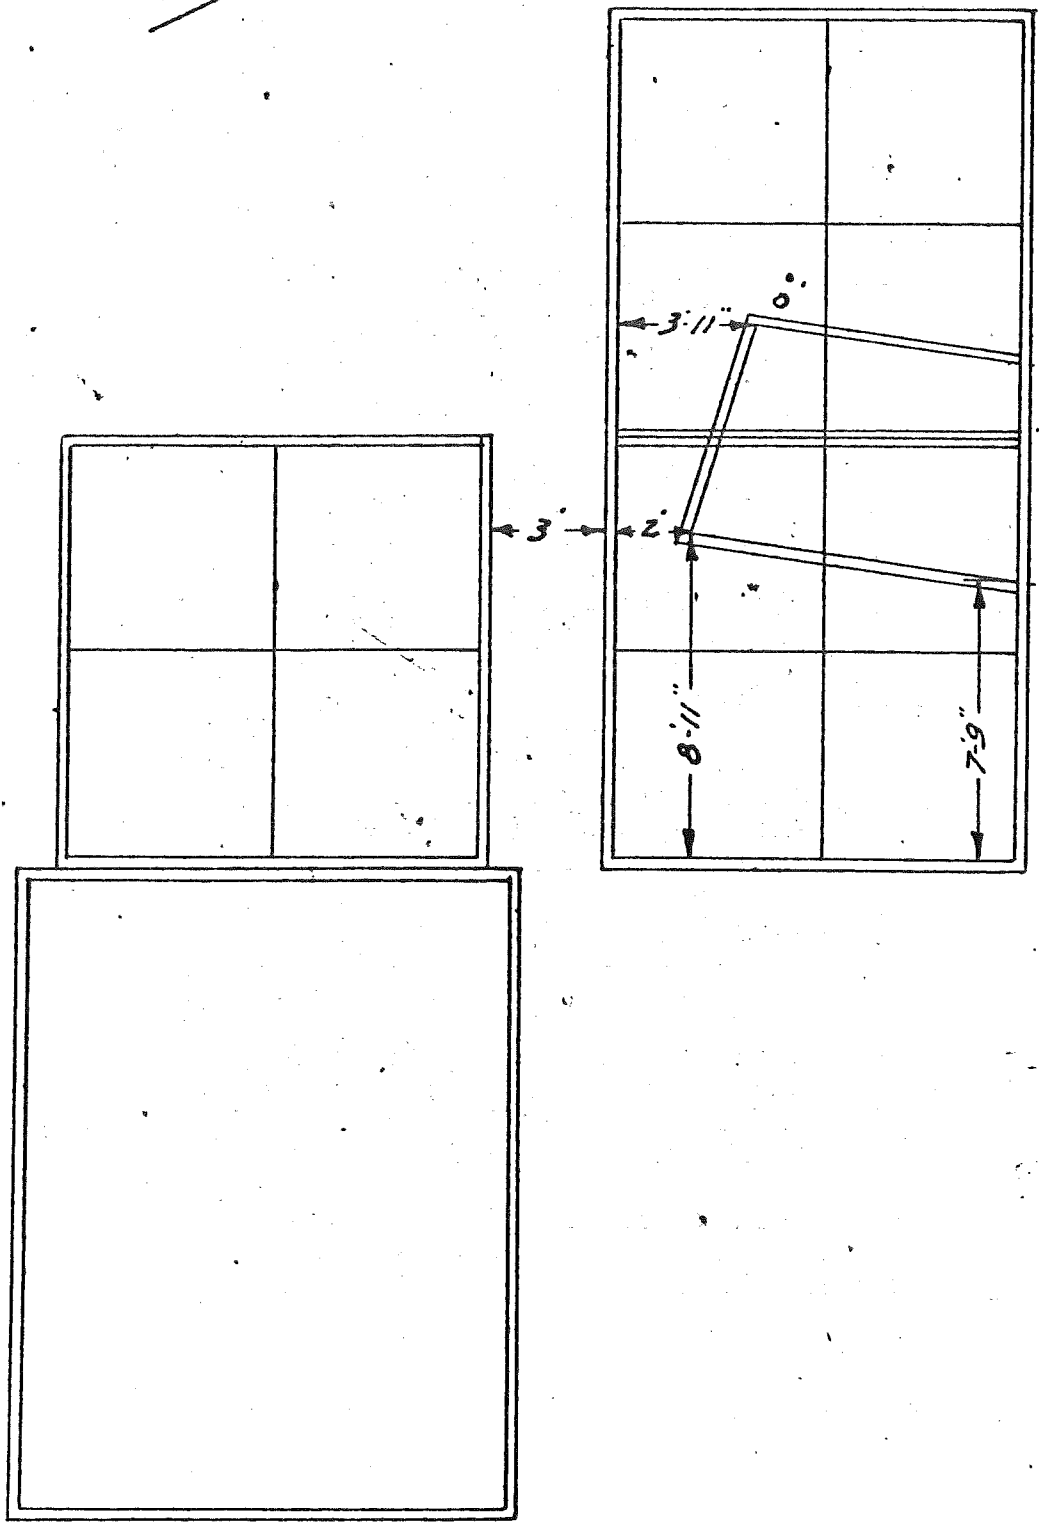
POSITION AT 50°

At the beginning these timbers were two feet away from the old shaft, leaving a void between the 8x8"s, and the wall of the pump shaft.

However at 50'-0 these timbers are close to the pump shaft, and some of them are 8x9" hewed timbers.

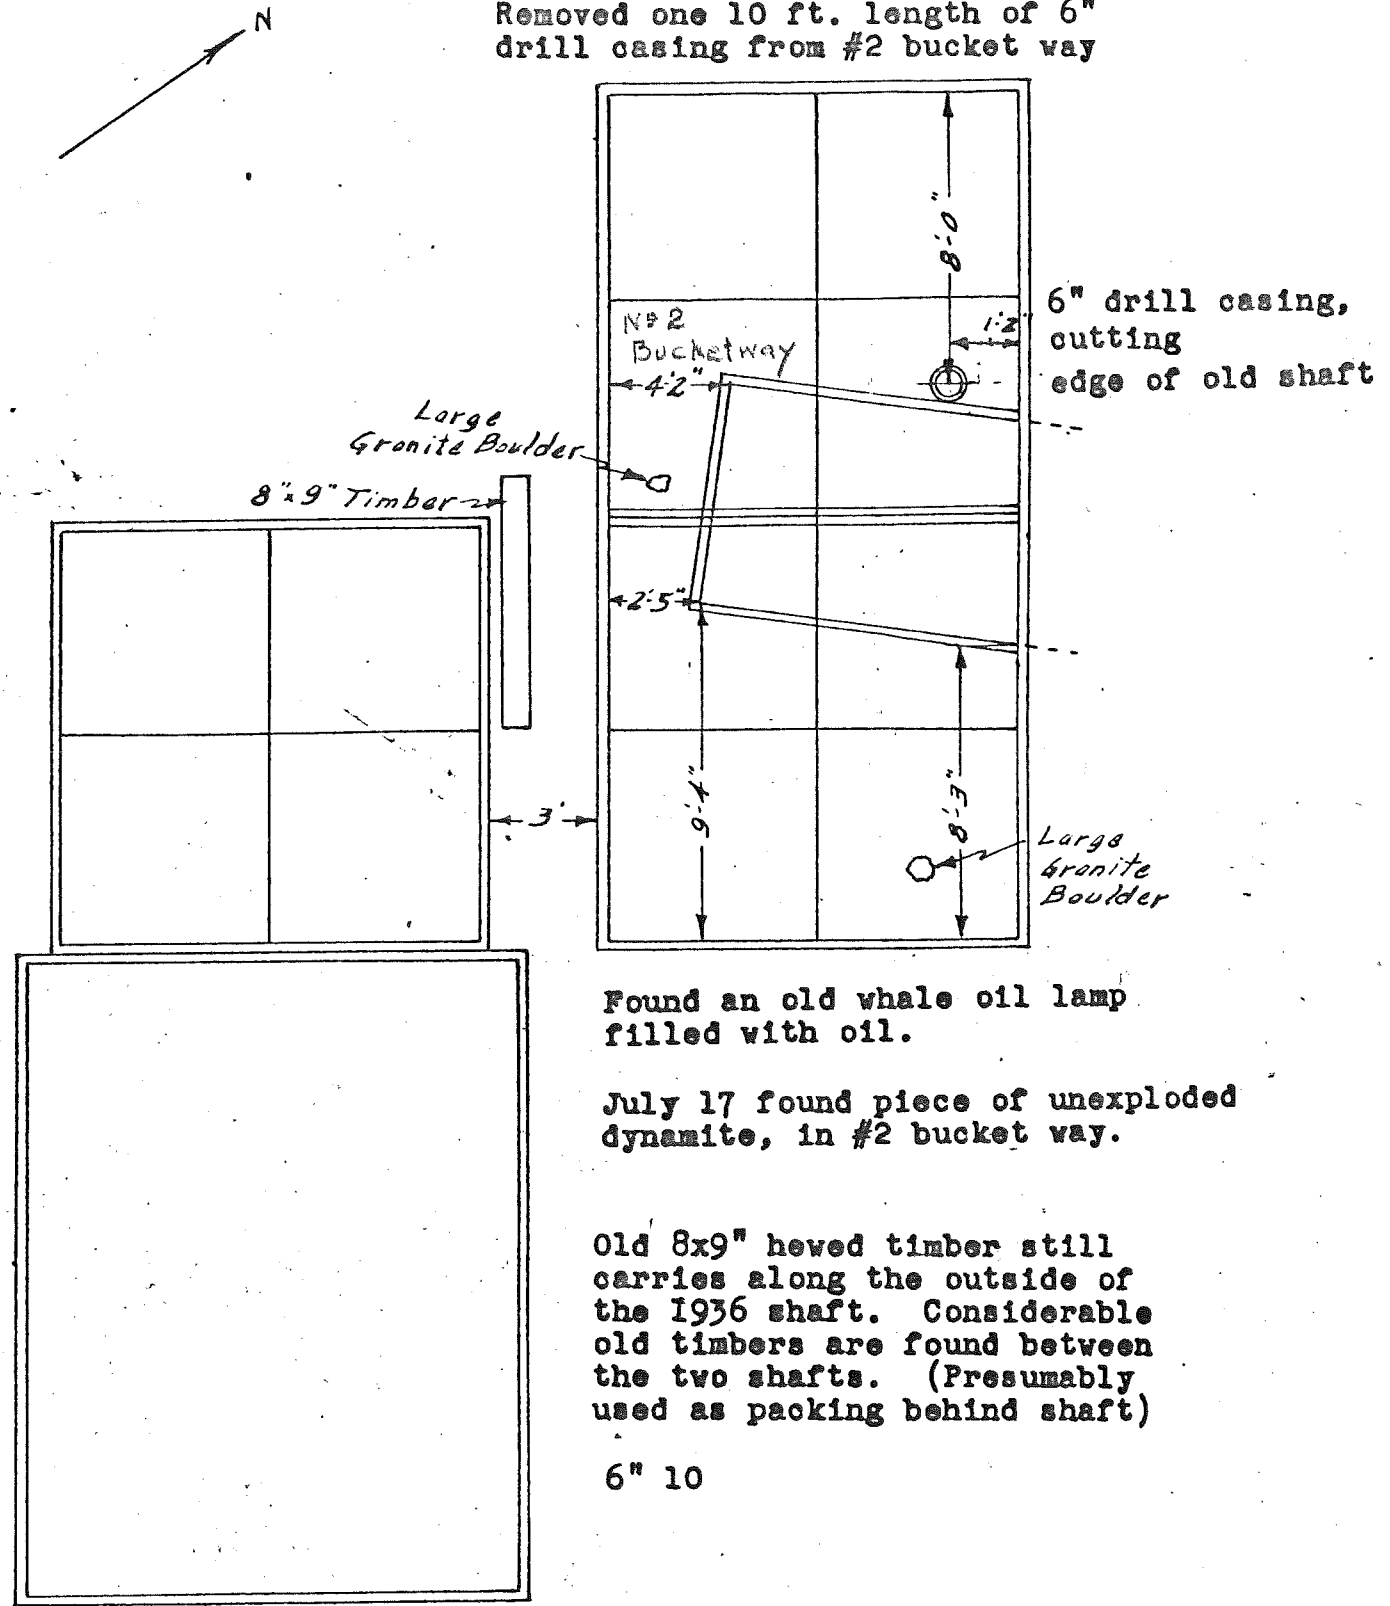
POSITION AT 65'

Found an old whale oil lamp filled with oil.

July 17 found piece of unexploded dynamite, in #2 bucket way.

Old 8x9" hewed timber still carries along the outside of the 1936 shaft. Considerable old timbers are found between the two shafts. (Presumably used as packing behind shaft)

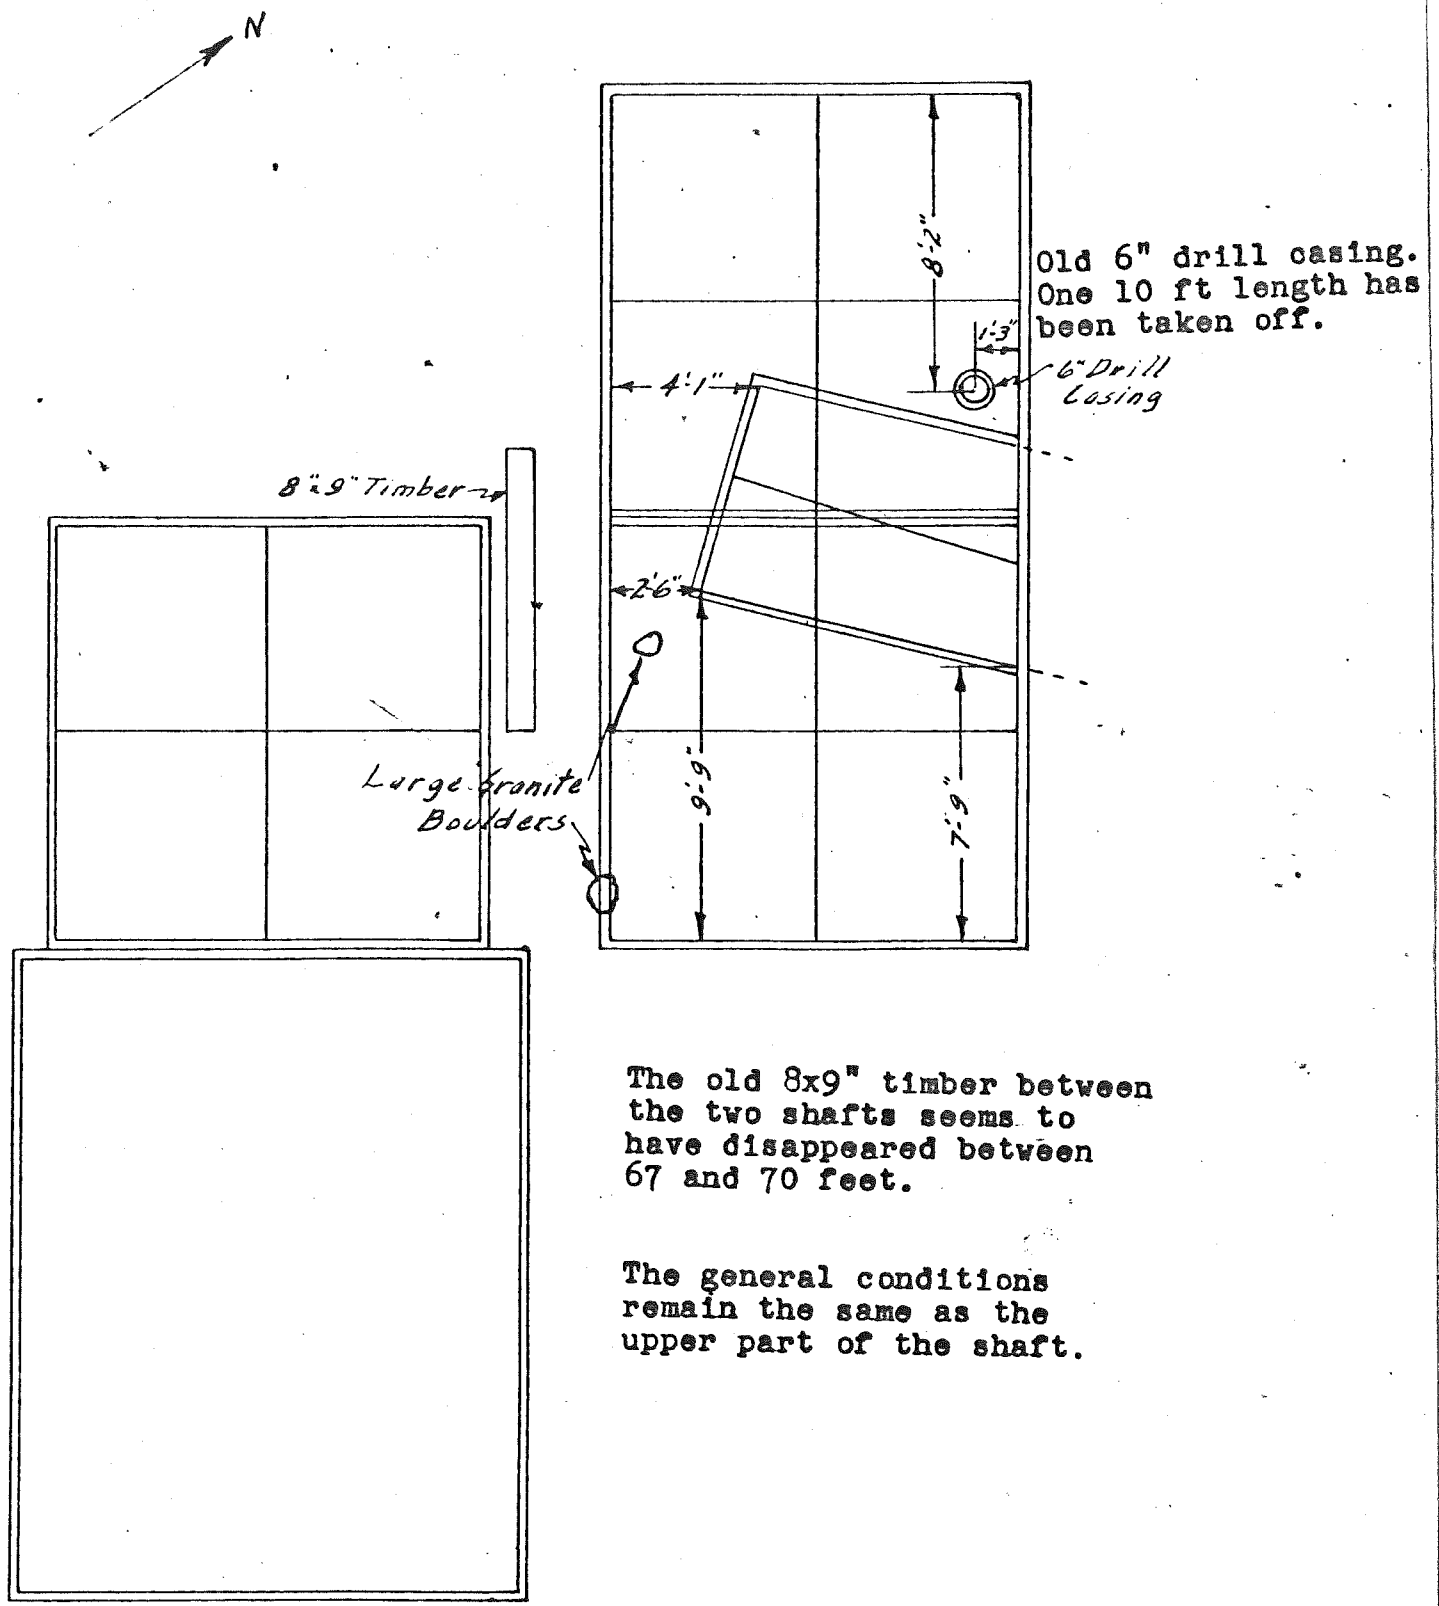
Sketch, showing new shaft between 65' and 70 ft.

The old 8x9" timber between the two shafts seems to have disappeared between 67 and 70 feet.

The general conditions remain the same as the upper part of the shaft.

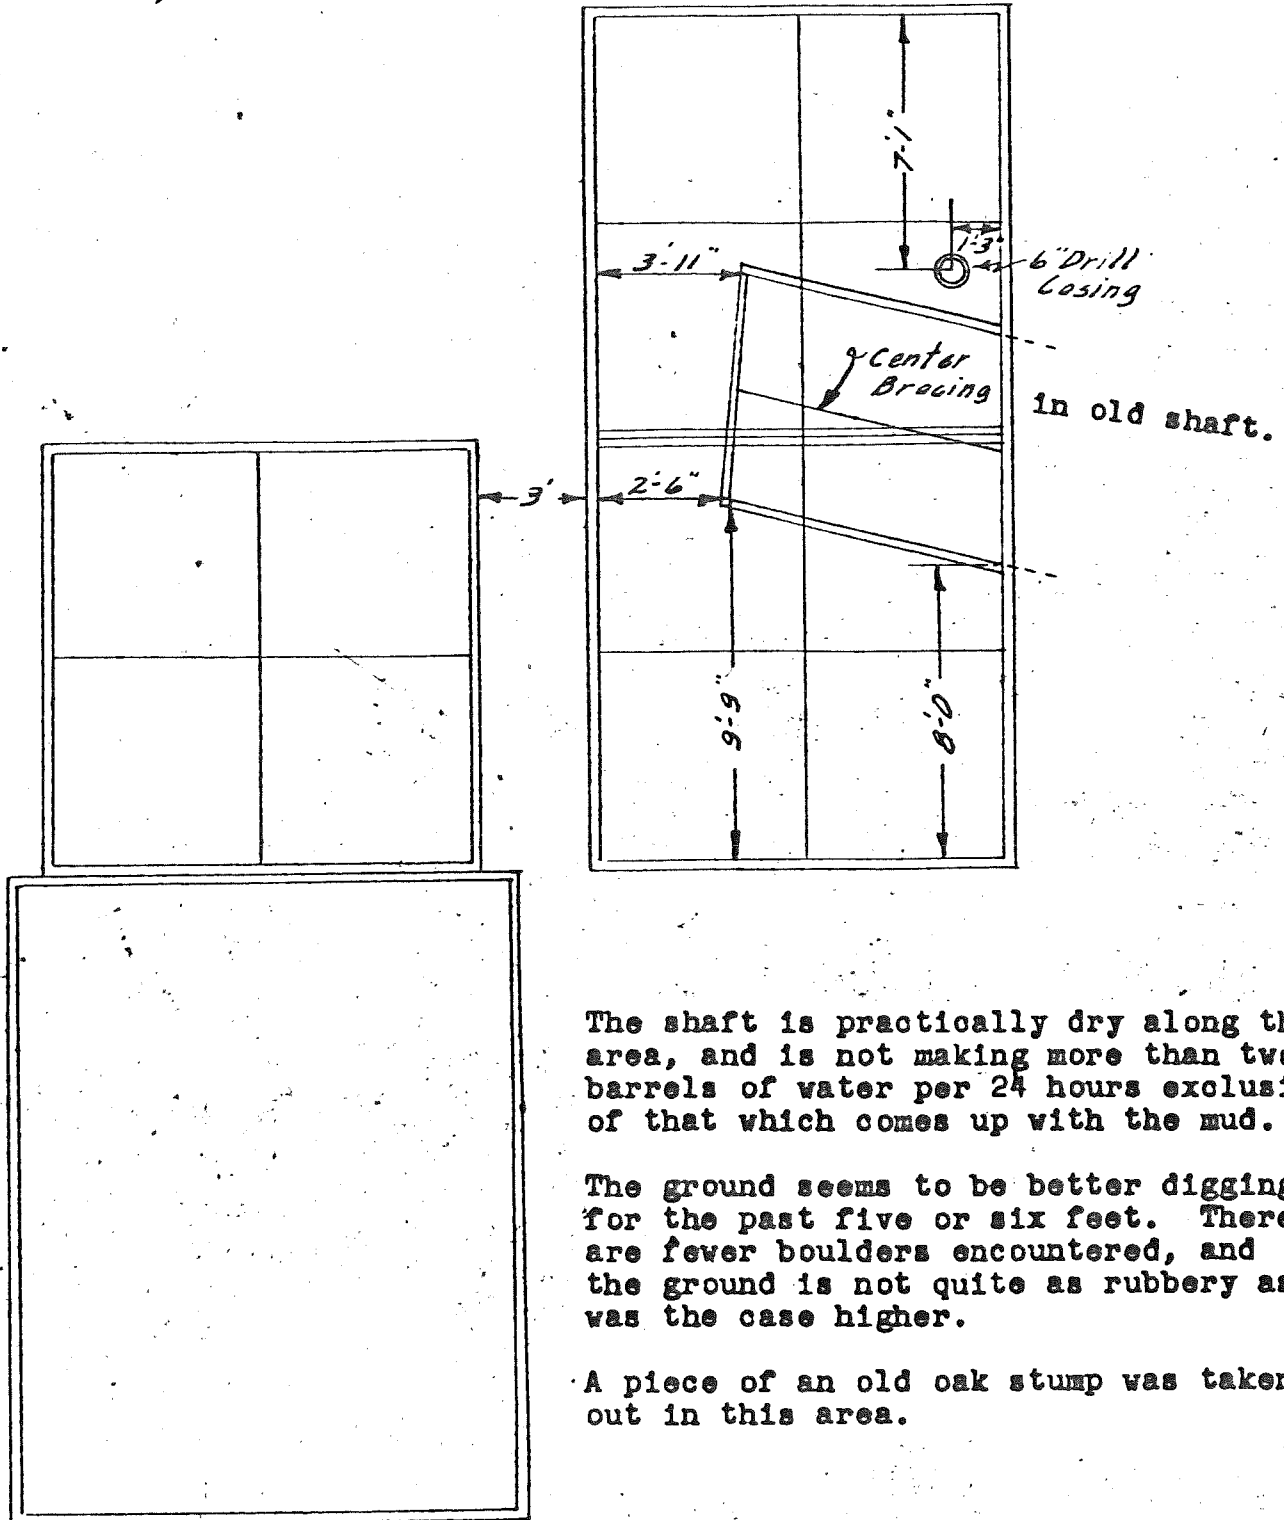
Sketch showing new shaft between
75' and 80'

The shaft is practically dry along this area, and is not making more than two barrels of water per 24 hours exclusive of that which comes up with the mud.

The ground seems to be better digging for the past five or six feet. There are fewer boulders encountered, and the ground is not quite as rubbery as was the case higher.

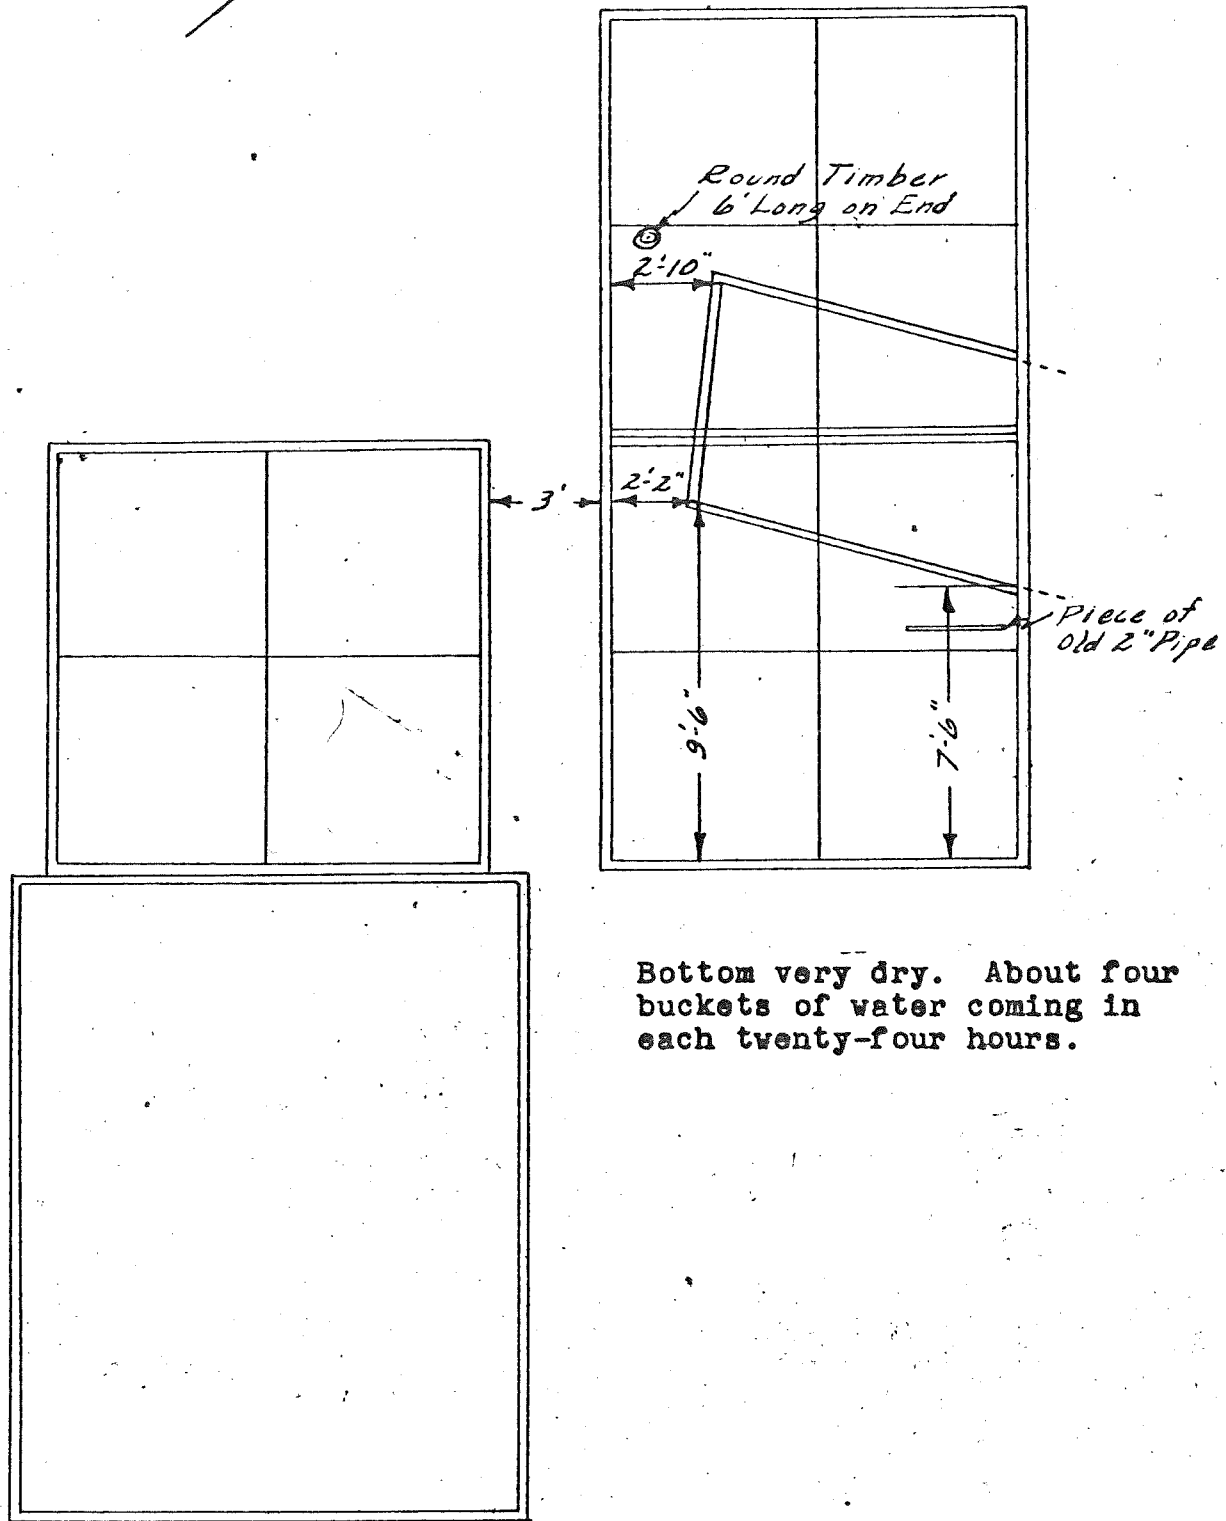
POSITION AT 85'

General conditions unchanged from last sketch.

Bottom very dry. About four buckets of water coming in each twenty-four hours.

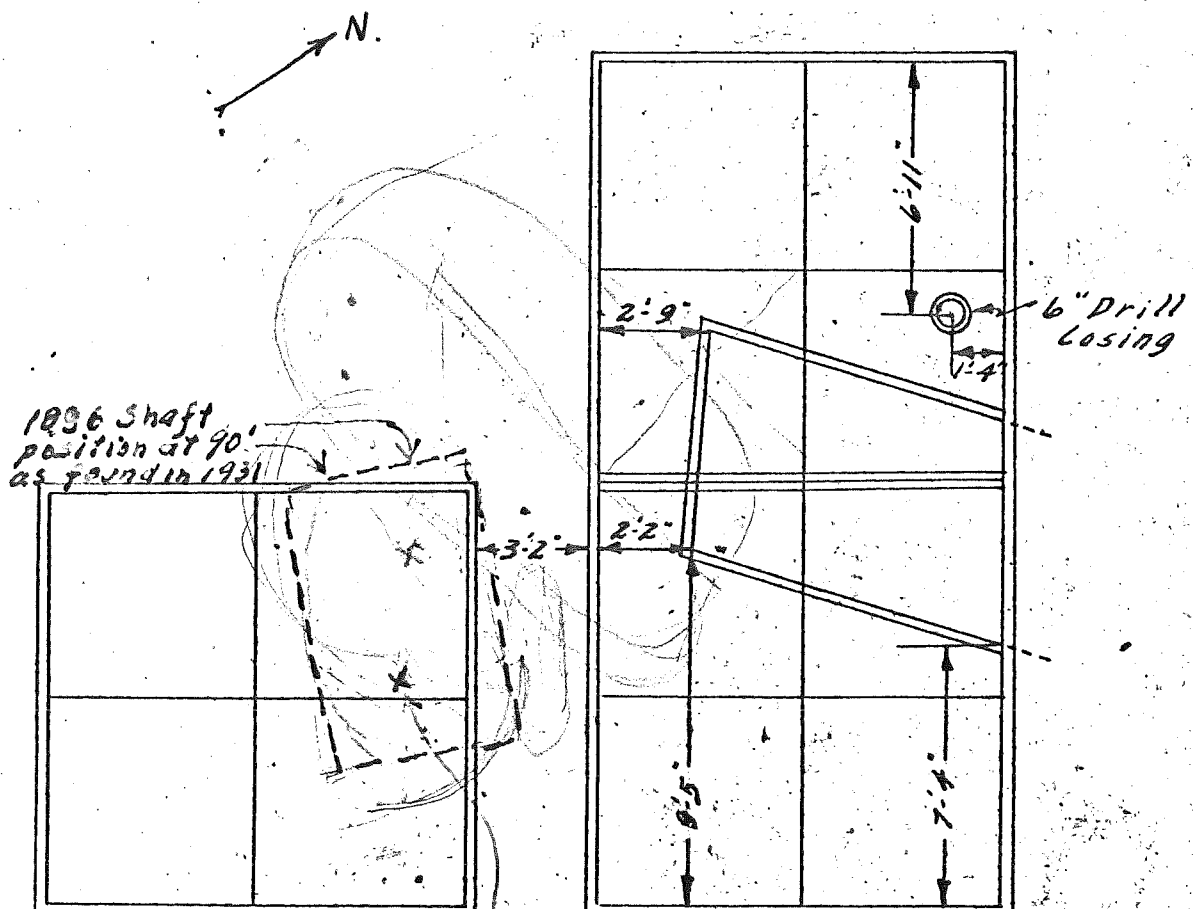
Sketch between 85 and 90 feet

In 1931: Chappell found Timber with bolt on which he had set the drill. When he drilled through the treasure in 1896 or 7. This is the location. This is the depth-90ft. (Present depth of timber with bolt.

Conditions unchanged, unless it seems slightly easier digging along the S.E. half of shaft.

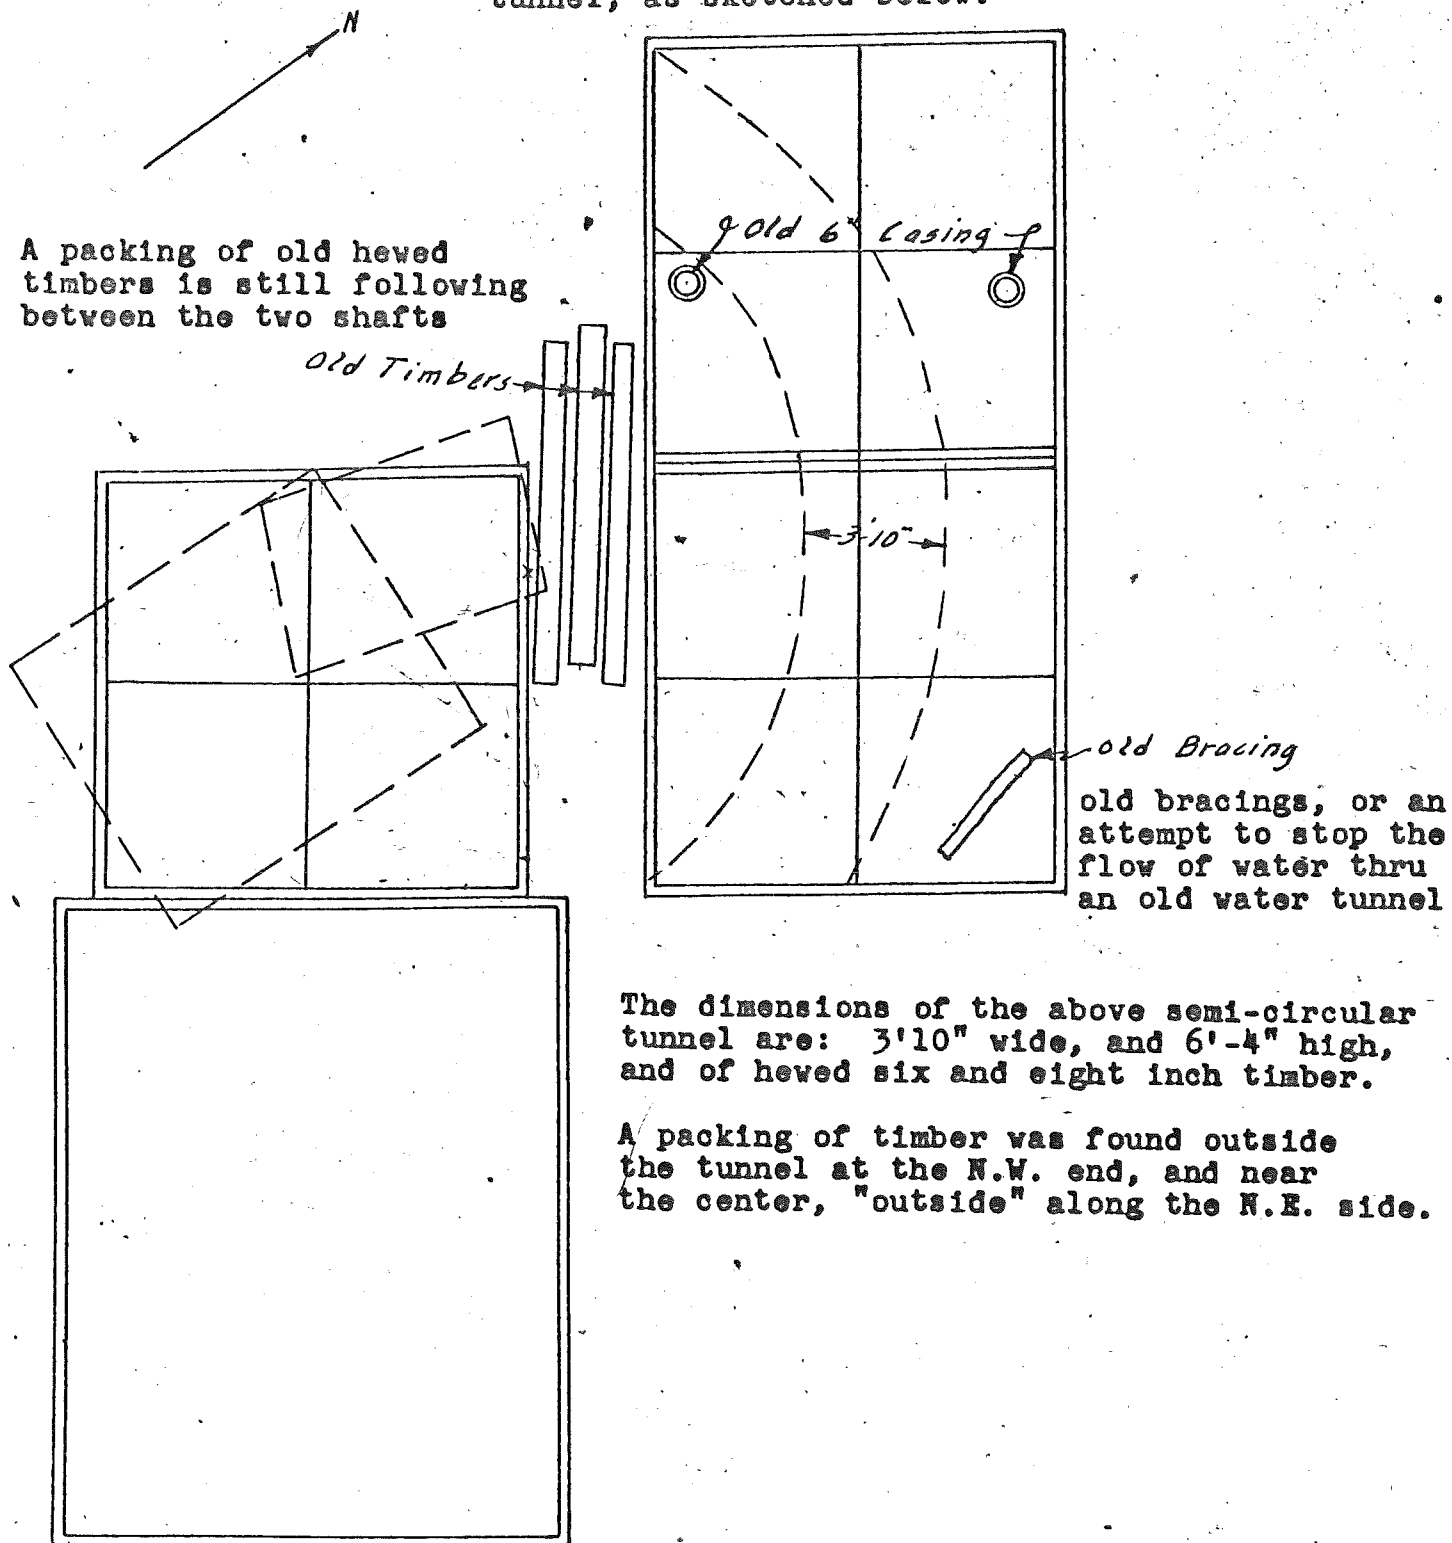
POSITION AT 102'

Sketch of shaft at 102-0 showing outline of an old semi-circular tunnel, as sketched below.

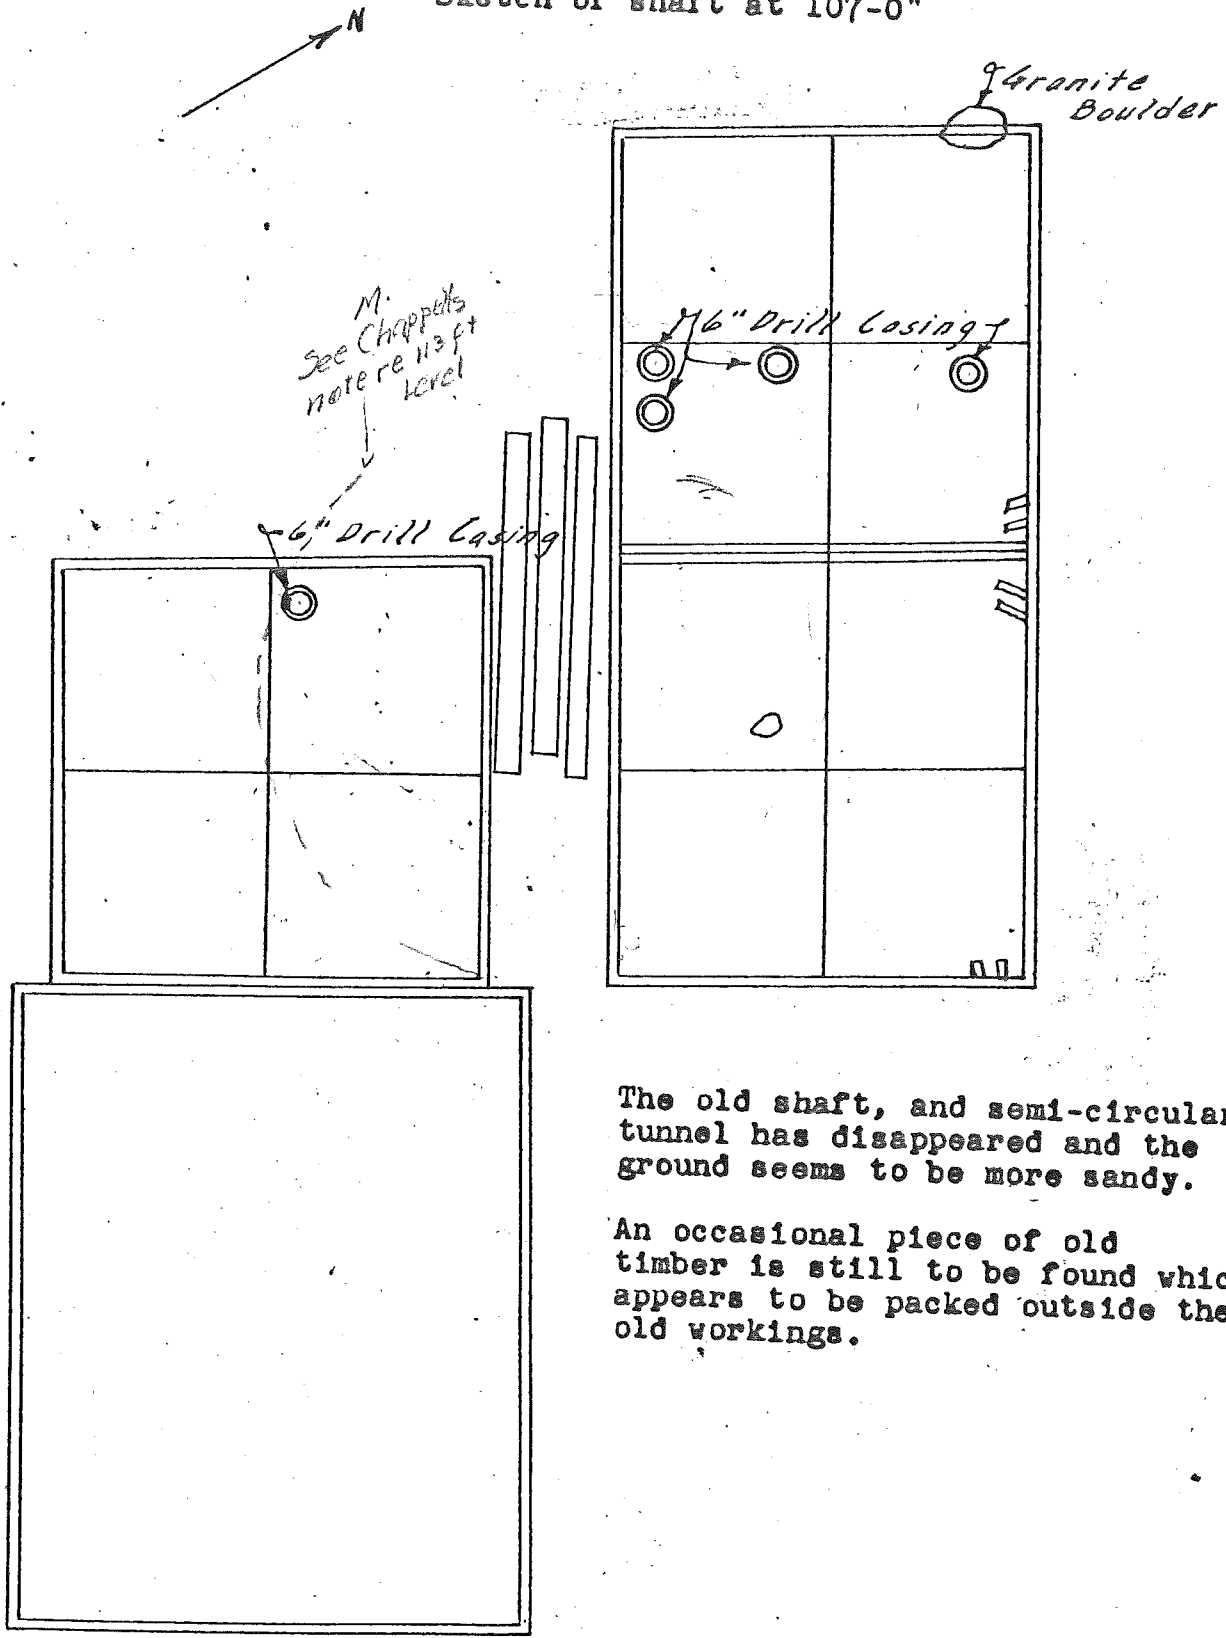
POSITION AT 107

The old shaft, and semi-circular tunnel has disappeared and the ground seems to be more sandy.

An occasional piece of old timber is still to be found which appears to be packed outside the old workings.
